*WELL  
RESTORATION*

*BUKSH  
MUSEUM*

**Appendix 02:**  
**House Repair Proposal**

Details for Repairing Basement and Terrace  
Bilochpura, Tajganj, Agra, 2014

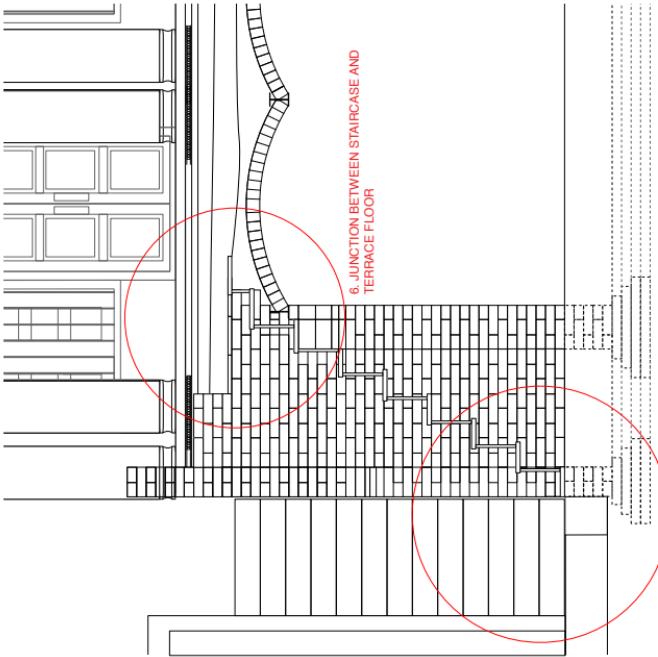
## 5. THRESHOLD AT STAIRCASE

- The signs are partly broken and mortal joints have worn away allowing cold and rain to come through the signs and basement floor.
  - With the stress areas there is:
  - Root holes have been created between the roof and the basement wall of the house.
  - Storm water has been created in the walls of the house.
  - The drain make the basement rooms unsightly and smell bad
  - Unknown at present whether holes against drain may have remaining structural integrity

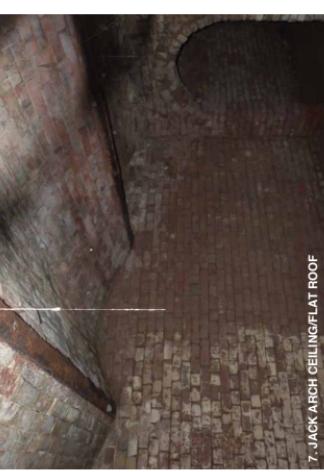
7. JACK ARCH CEILING/FLAT ROOF  
(view above)

- Because the limestone floor used to have worn away (at some point the bricks of the jack arch actually lay through in the floor of the terrace above) and on top of this water could easily have become trapped in the floor slab, causing it to rot. The limestone floor is relatively ‘dry’ probably as a result of the lime concrete slab rubbers.

- It appears that the original slab is a mix of large aggregate and smaller fine aggregate. It would be better to use a mix with smaller aggregate. This would perhaps have created some level of heat insulation.

- The floor just outside the family room needs to be checked under these conditions. It probably contains pizzoccarelli material to better water runoff. This is probably what the rest of the terrace floor was covered with when it was constructed. This may well have been exacerbated by a reduction with time from the pointing and slab above. The detail of how the slabs were protected from the lime wash seems to have been lost over time. The basement rooms have not suffered at times been very moist, causing corrosion too.

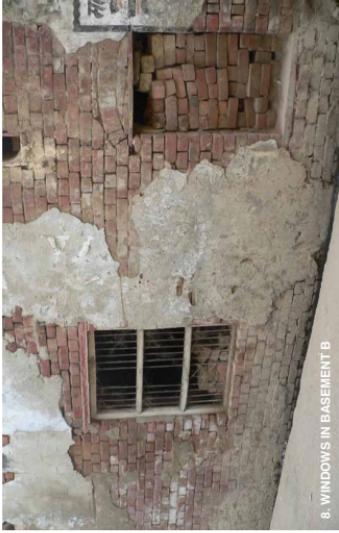
8. WINDOWS IN BASEMENT B

- Lucky, most of the openings to the basement rooms have a brick arch lintel; this has saved the building because the stone lintels have been removed from windows in the Old Guesthouse upstairs, causing the building to partially collapse.
- One window in Basement Room A has a broken stone lintel which probably held a stone rainwater head; the new window above it is This, somewhat combined with timber shatters was how windows were converted to doors. This is the case with all the windows.
- Window and opening in other rooms:

- Timber door (rotten) with timber frame (rotten)
  - Timber framed window frame (rotten) with simple grille (damaged)

- Sealsills are worn from non-existent - old details are makeshift

- Lack of or no weathering protection from rain for the basement rooms, and they also get very cold in winter.

- Plaster and brick cornice above is broken - no longer throws rainwater away from the windows.

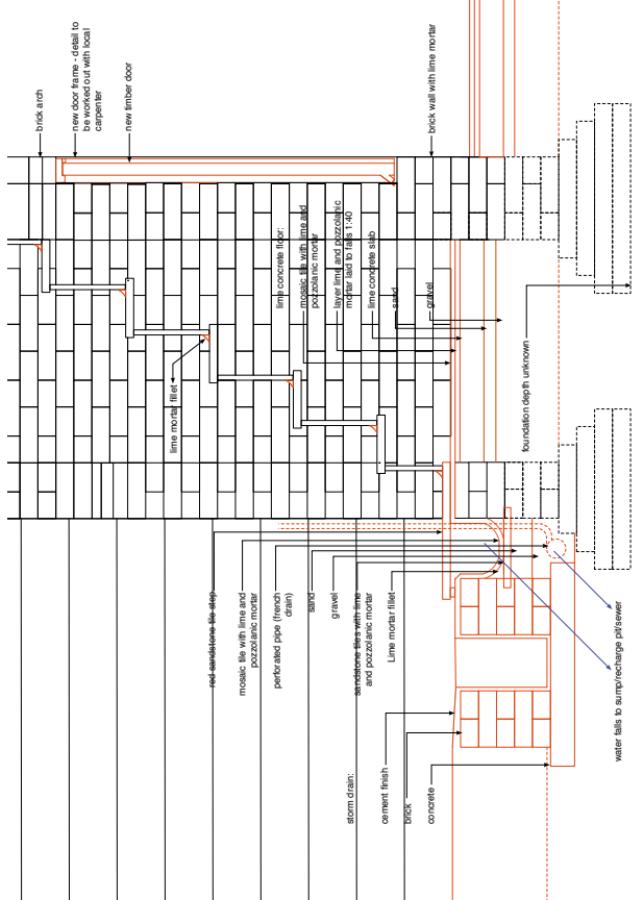
PROPOSED DRAIN OPTION 1: USED IF FOUNDATION WALL IS FOUND TO STILL HAVE STRUCTURAL INTEGRITY

### 5. THRESHOLD AT STAIRCASE

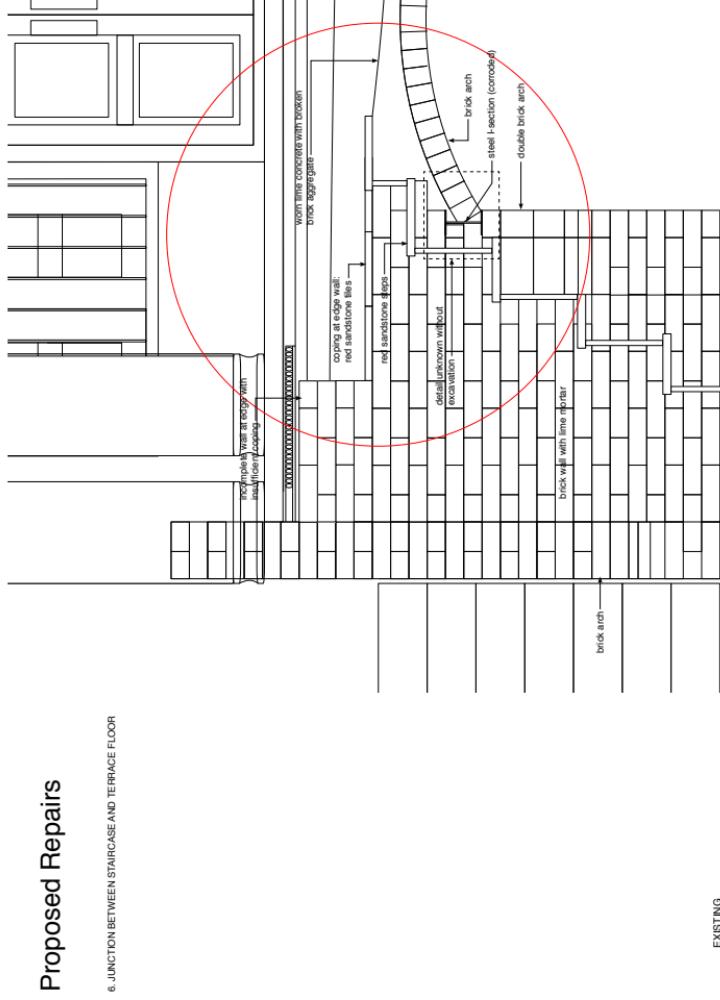
EXISTING

6. JUNCTION BETWEEN STAIRCASE AND TERRACE FLOOR

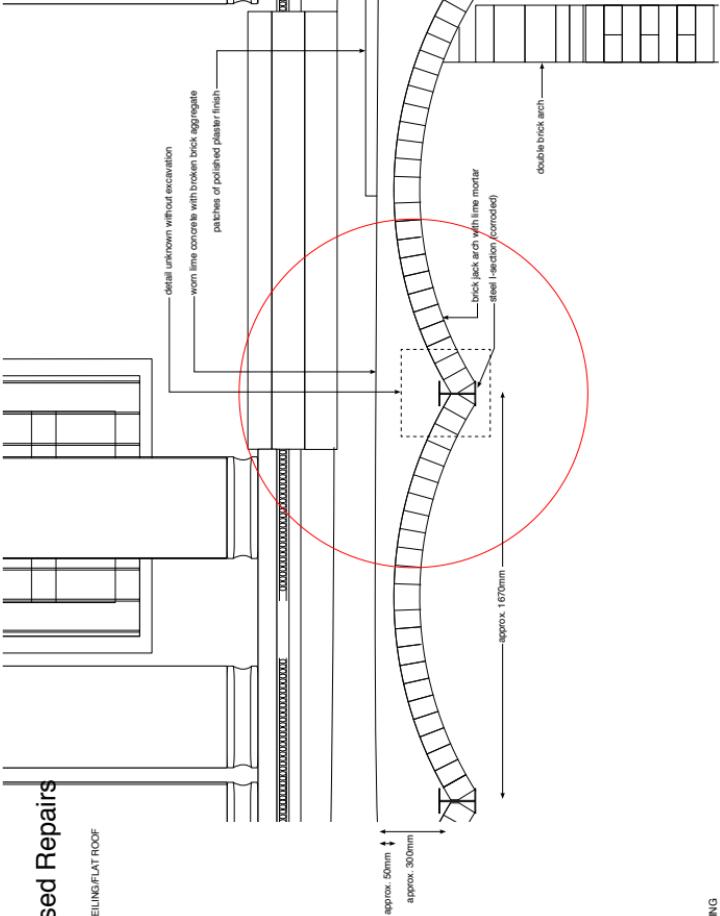
EXISTING

7. JACK ARCH CEILING/FLAT ROOF

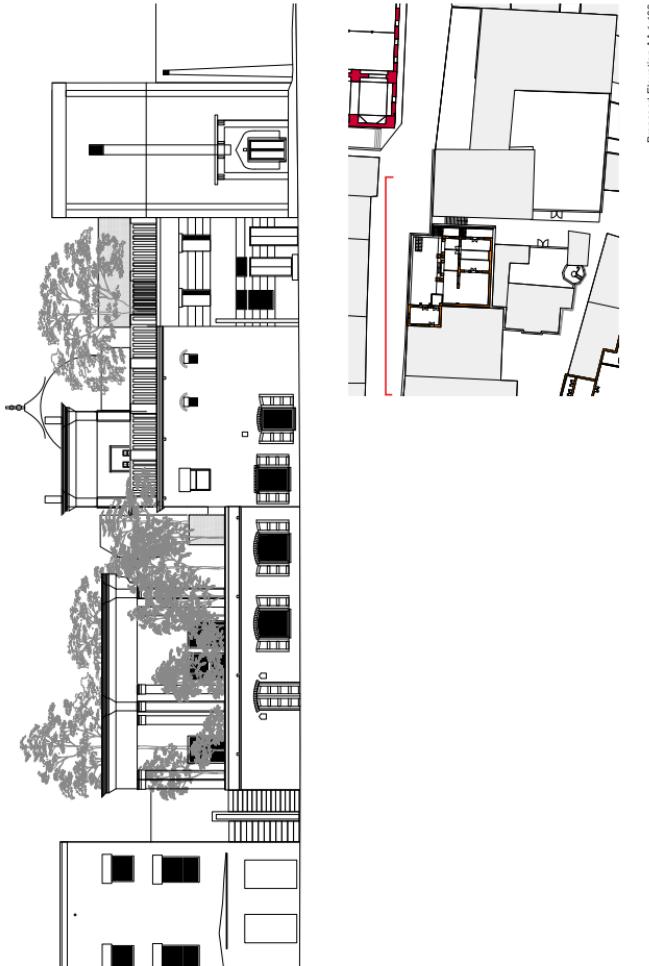
Existing Elevation AA 1:100

## 8. WINDOWS: Effects on Elevation
