Some Aspects of Crack Initiation in Mild Steel Subjected to  
Fatigue Stressing in a Corrosive Environment

G P Ray BSc MSc CEng MIM MICorrT MIMF

A report presented in partial fulfilment of the requirements  
of the PhD Degree of COUNCIL OF NATIONAL ACADEMIC AWARDS.

City of London Polytechnic  
Sir John Cass School of Science  
and Technology  
Department of Metallurgy and Materials  
LONDON

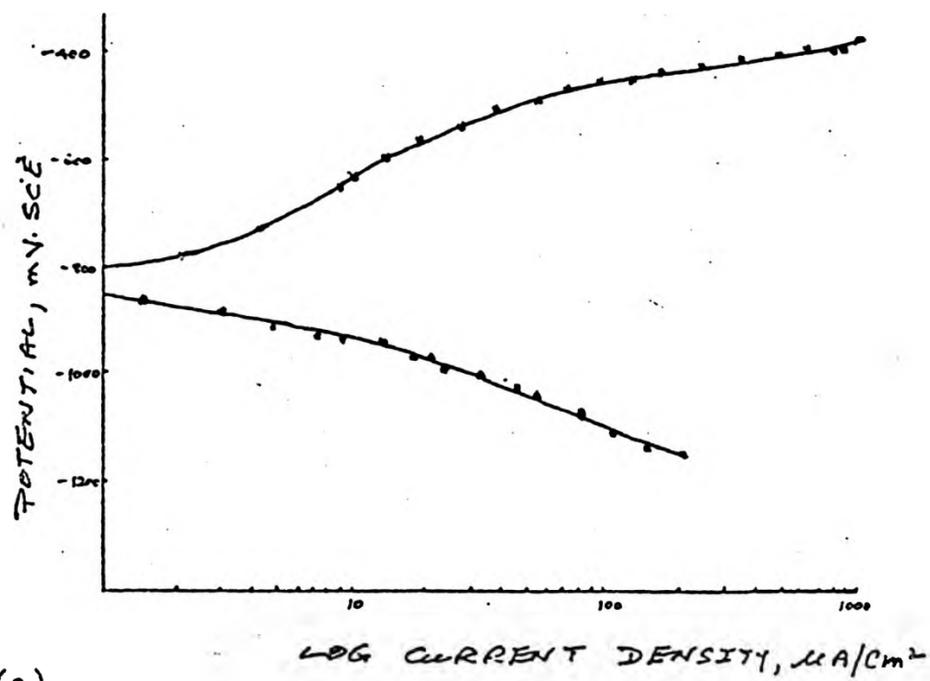
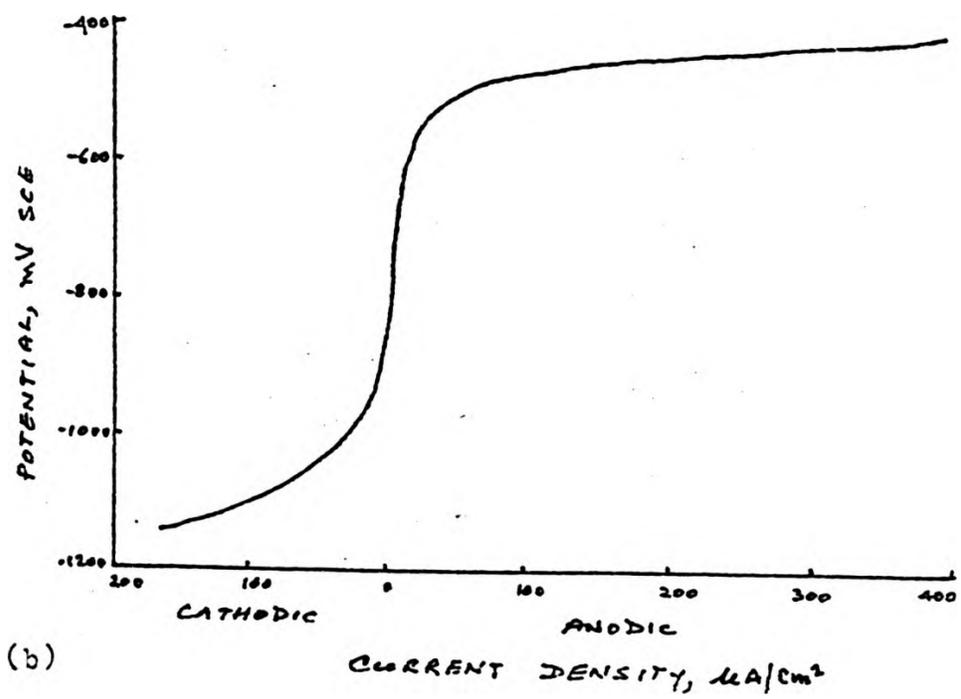
Fig R 1: Typical potentiostatic polarisation curve for mild steel in 0.6 M sodium chloride solution in stagnant condition without an applied stress. Current density is plotted on (a) log and (b) linear scales.

Typical potentiostatic curves, in aerated 0.6 M sodium chloride solution of pH 6.5 with and without stress, are shown in Figures R 1a to R 3a. These curves have been re-drawn with current densities on expanded linear scales to clarify the peak positions in the curves (Figures R 1b to R 3b). Typical potentiokinetic polarisation curves are shown in Figure R 4.

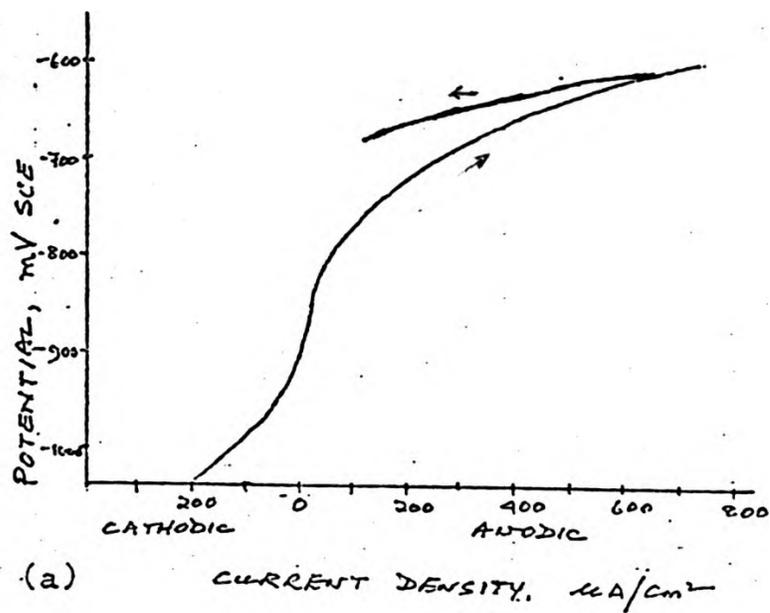
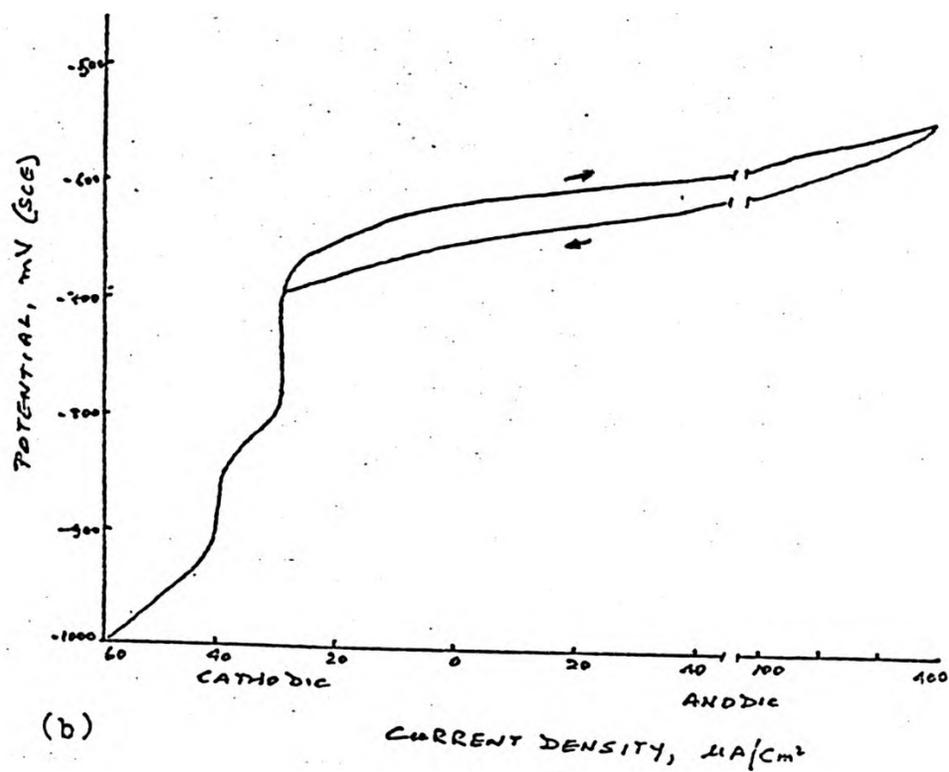
Fig R 4: Typical potentiokinetic polarisation curves for mild steel in 0.6 M sodium chloride solution in (a) stagnant and (b) flowing electrolyte conditions without an applied stress.

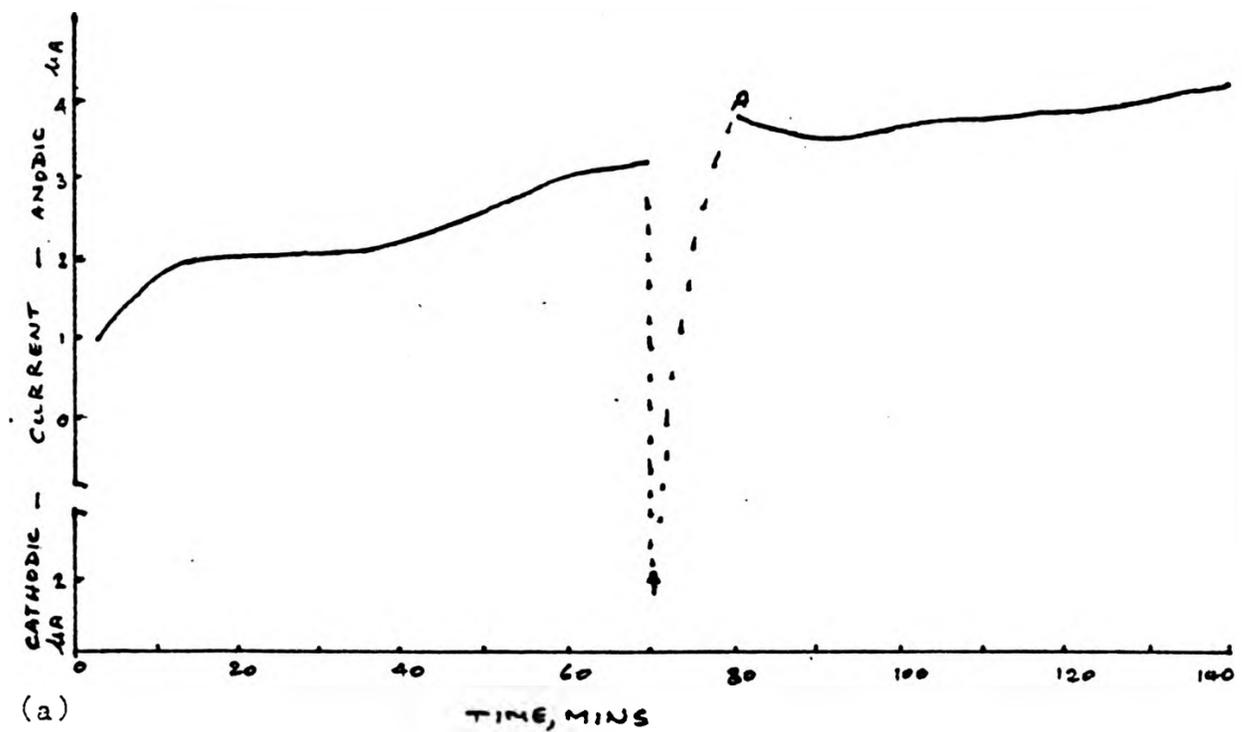
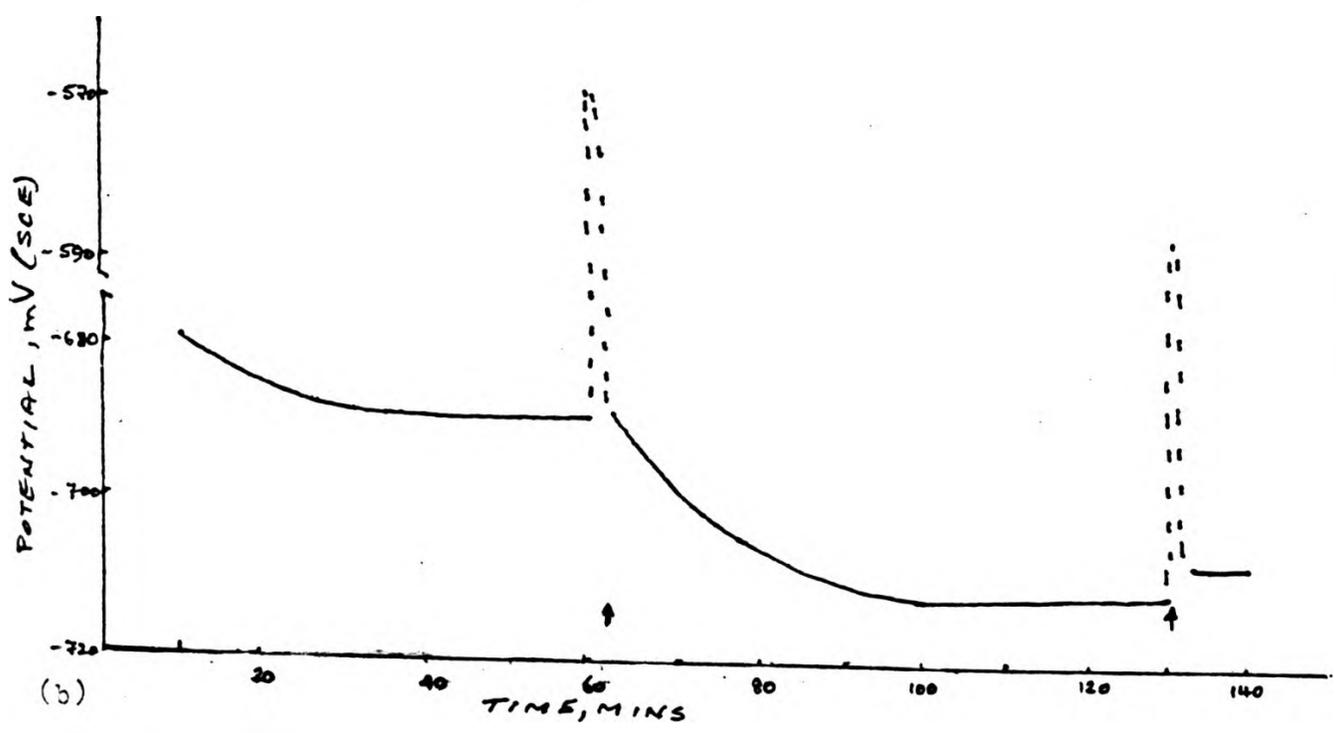
Fig R 5: Typical current and potential curves for mild steel in 0.6 M sodium chloride solution in flowing electrolyte. Arrows indicate scratching of the specimen surface. Current vs time and potential vs time curves are shown in (a) and (b) respectively.

Figure R 5b shows the potential against time curve after the steady state was nearly achieved. The removal of the surface film with a glass rod exhibited a change in potential in a more positive direction. The return of the potential to its original value was practically instantaneous. Subsequently it moved to a more negative direction than that obtained prior to the scratching of the specimen surface.

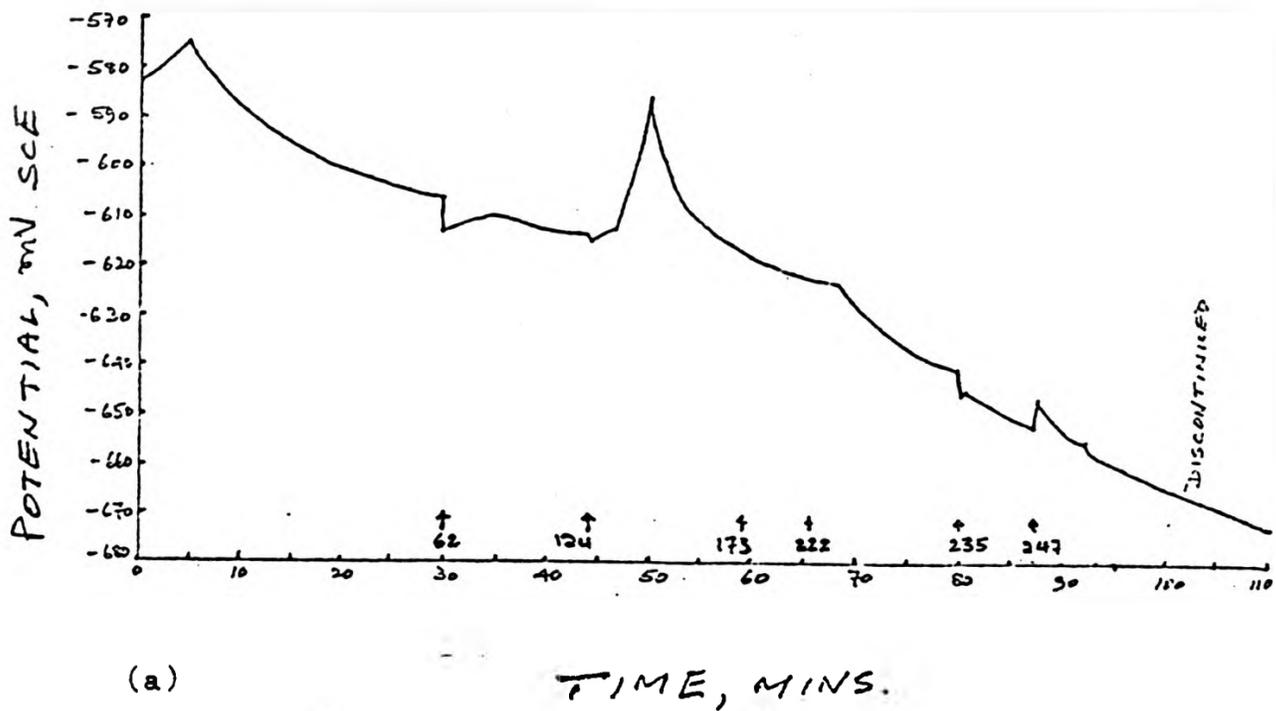
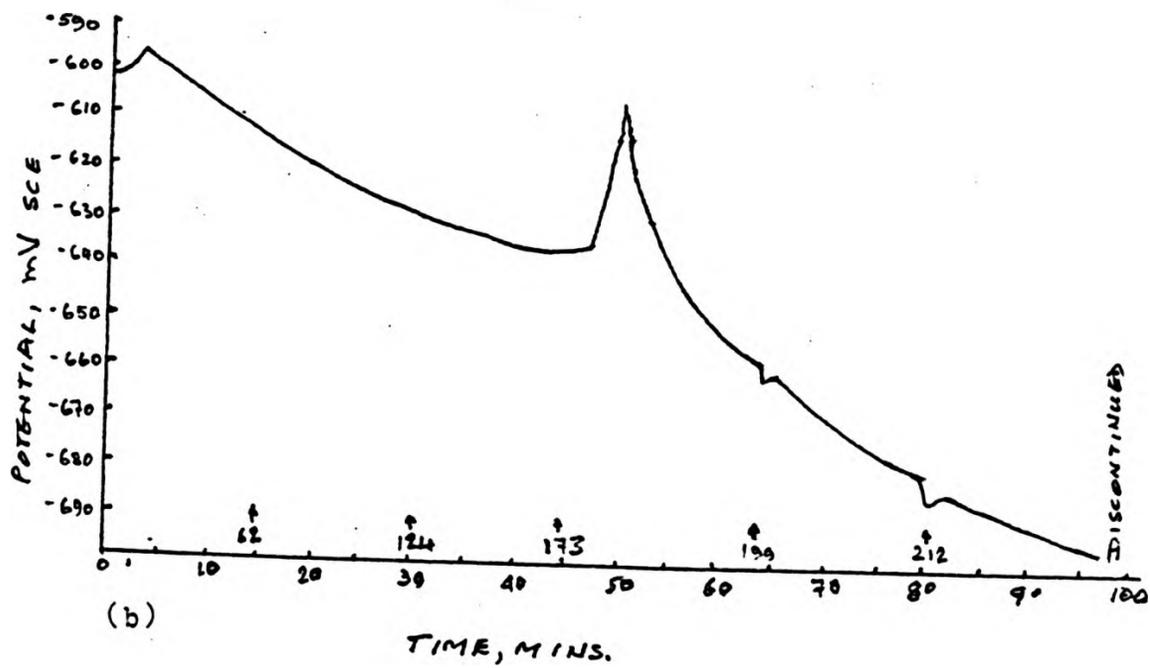
Fig R 7: Typical potential vs time curves for mild steel in 0.6 M sodium chloride solution with applied tensile stress for (a) annealed and (b) wrought material. Fig R 7 (c) shows potential vs time curve for wrought material in 0.1 M sodium hydroxide solution.

To observe whether the potential shift was due to the mechanical breakdown of a protective surface film, the wrought material was tested in a solution of 0.1 M sodium hydroxide solution, pH 12.5,

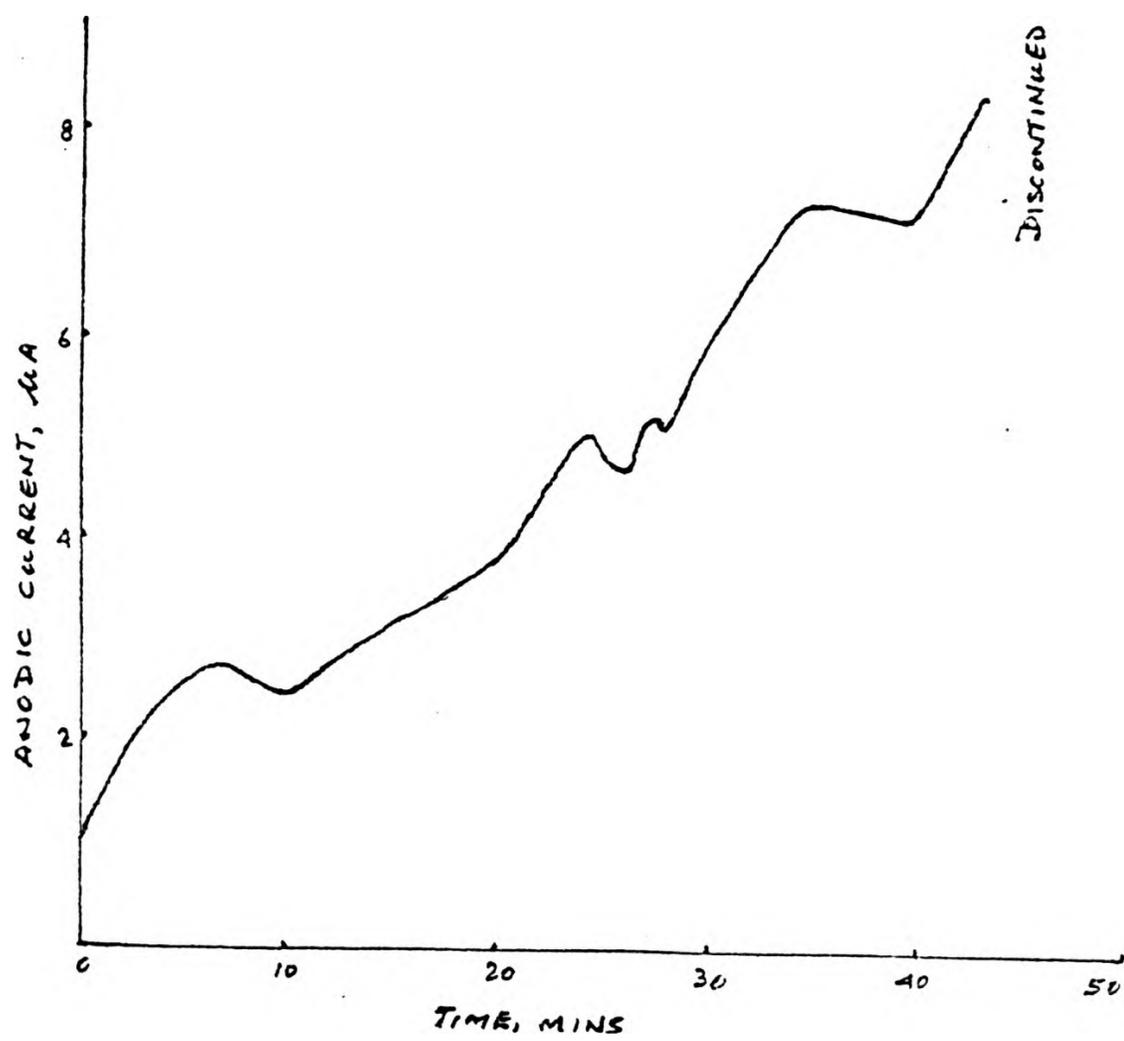
(a) Corrosion current vs time curve at zero stress in stationary condition at an applied potential of -650 mV (SCE).

Fig R 8: Typical curves for mild steel in 0.6 M sodium chloride solution.

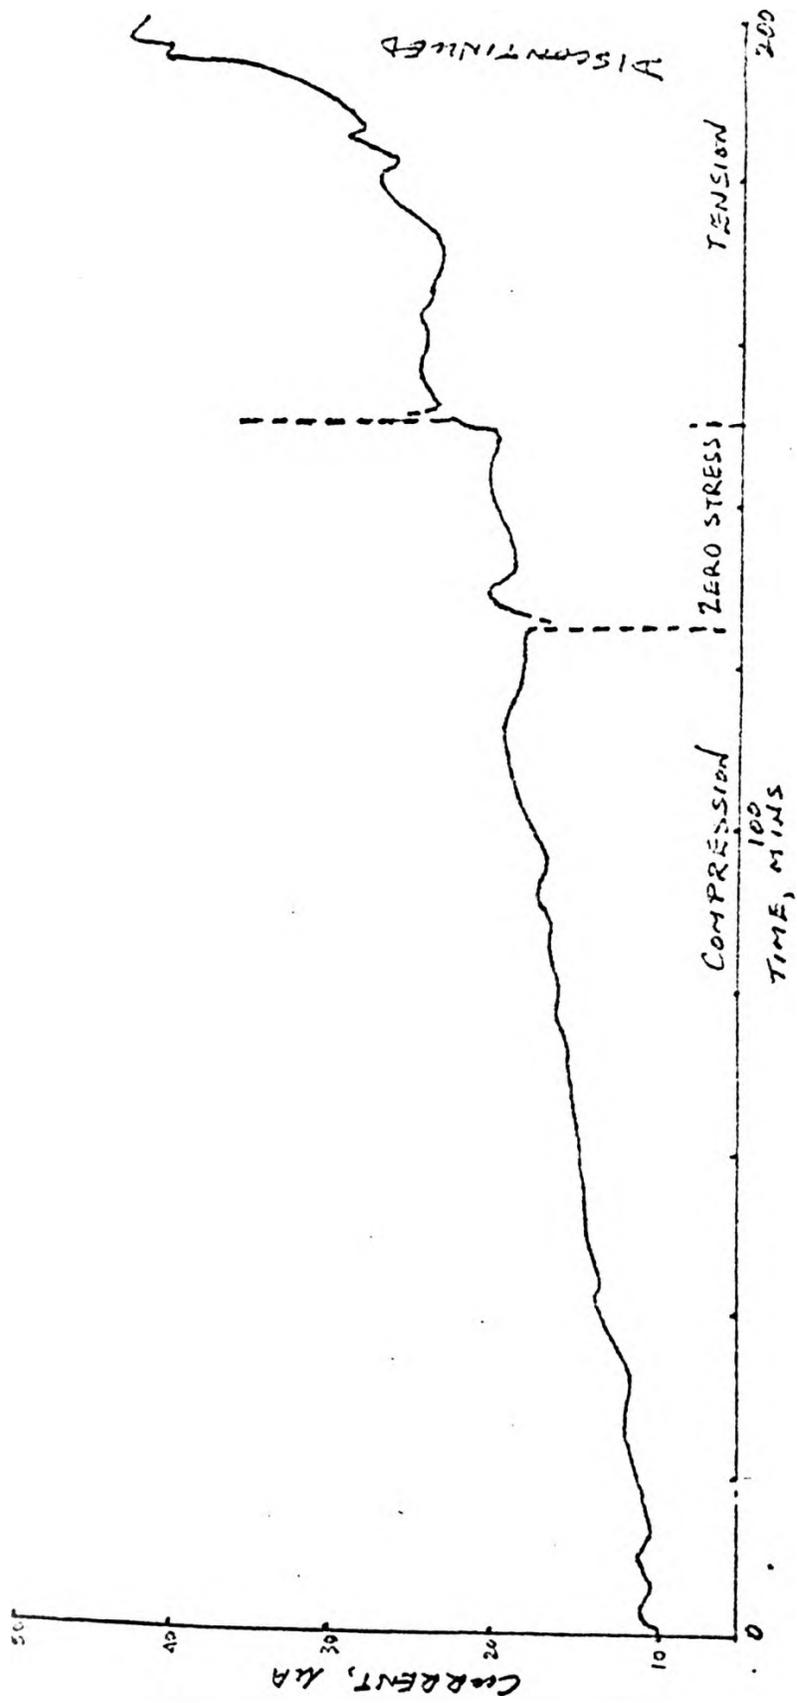
(b) Corrosion current vs time under compressive and tensile stress in stationary condition at  $-660$  mV (SCE) applied potential, 200 MPa.

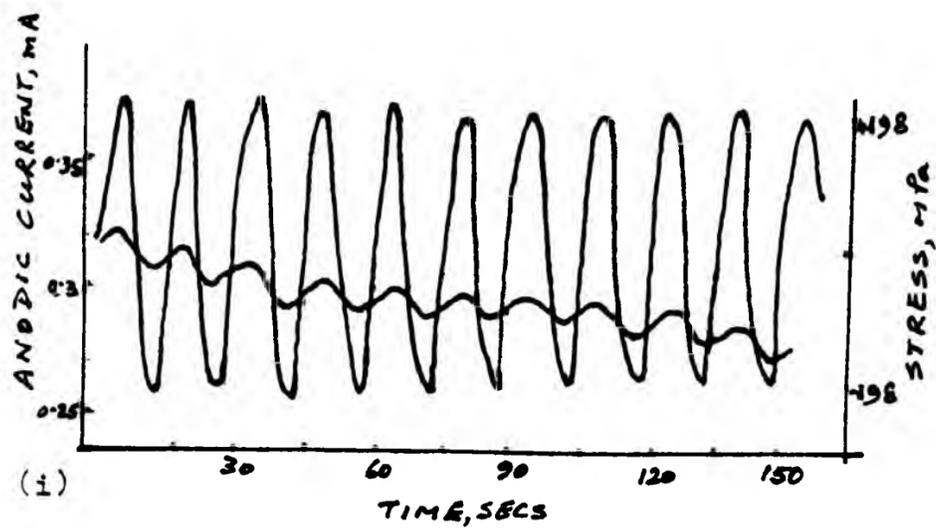
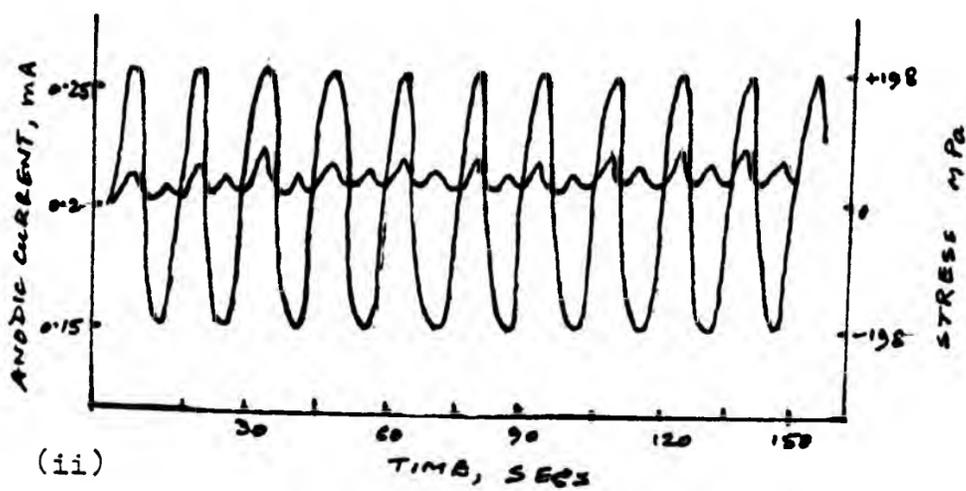
(c) Anodic current and stress as a function of time for a specimen under cyclic stress, 198 MPa,  $R=-1$ , at 0.07 Hz with an applied potential of -560 mV (SCE).

The stress/current vs time relationship over the first few cycles for tests carried out at 198 MPa,  $R = -1$ , with an applied potential of -560 mV (SCE), at 0.07 Hz, are shown in Figure R 8c.

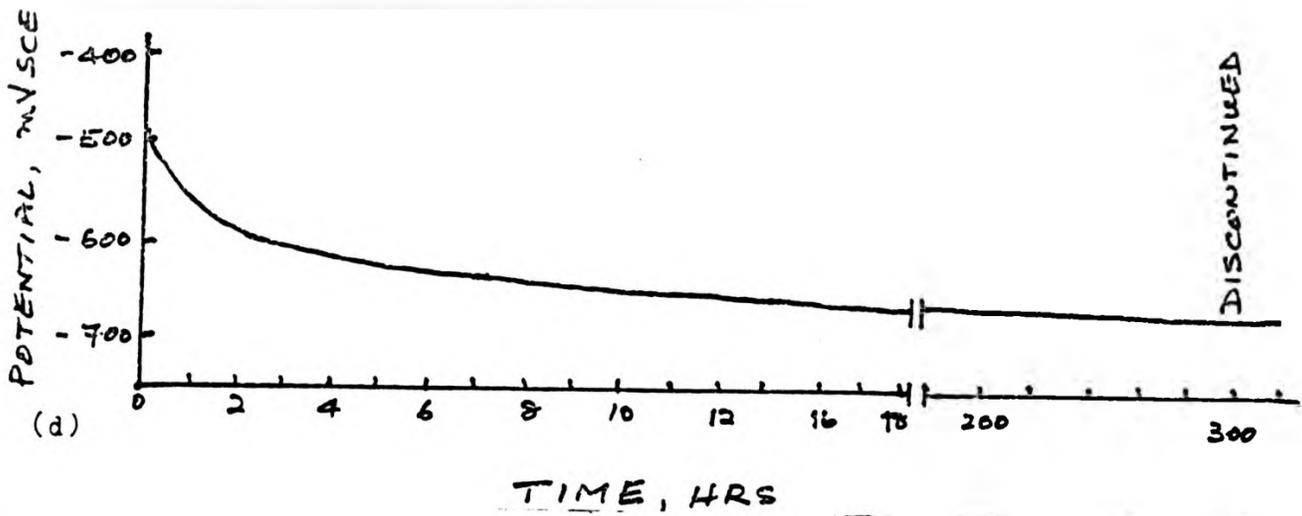
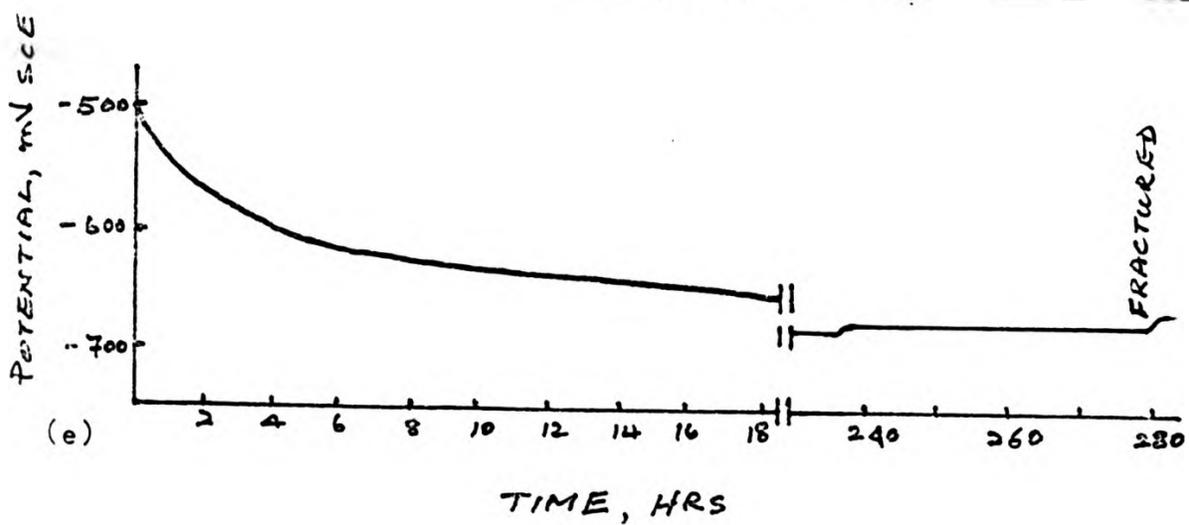
Potential vs time curves (d) at zero stress in stationary condition and (e) with an applied cyclic stress of 198 MPa,  $R=-1$ , at 0.2 Hz. Corrosion current vs time curve at 198 MPa,  $R=-1$ , 0.2 Hz is shown in (f).

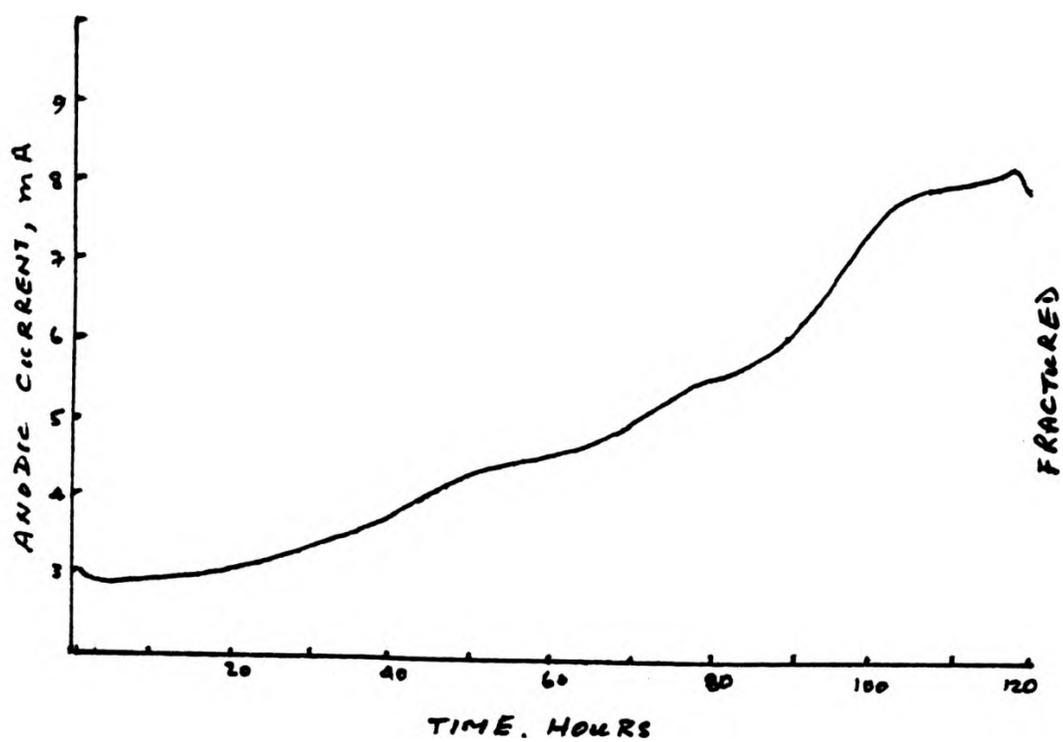
(g) Corrosion current vs time curve at 247 MPa,  $R=-1$ , 0.2 Hz with an applied potential of -560 mV (SCE).

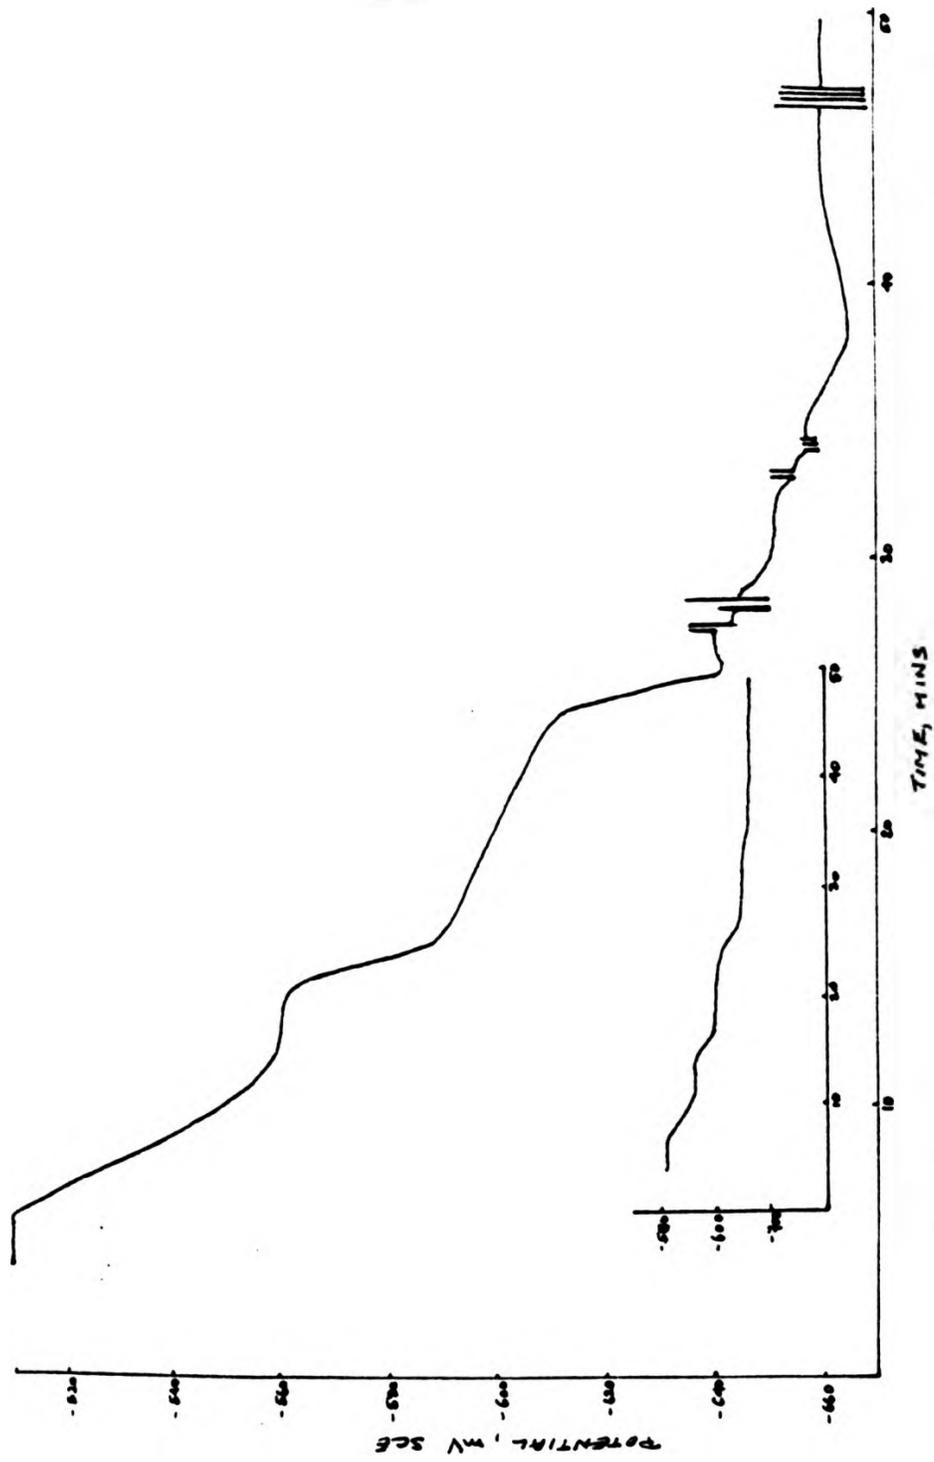
(h) Potential vs time curve with an applied stress of 247 MPa,  $R=-1$ ,  
0.02 Hz.

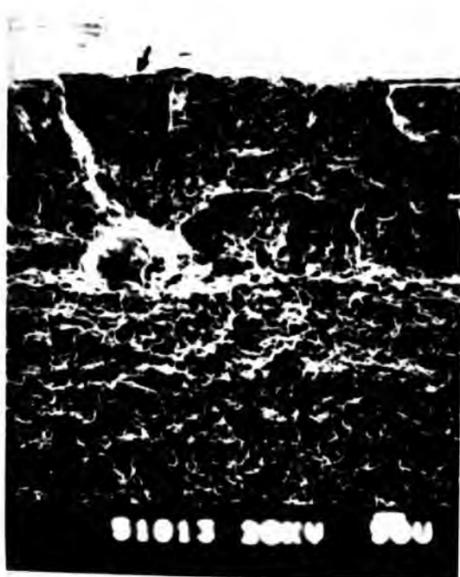
Typical (a) potential vs time and (c) corrosion current vs time curves for polished mild steel specimens in 0.6 M sodium chloride solution at 170 MPa,  $R=-1$ . The applied potential for (c) is -560 mV (SCE). (b) Fracture surface of a potential vs time (a) curve specimen after 300 minutes. Arrow indicates the presence of a pit from which a crack appears to emanate.

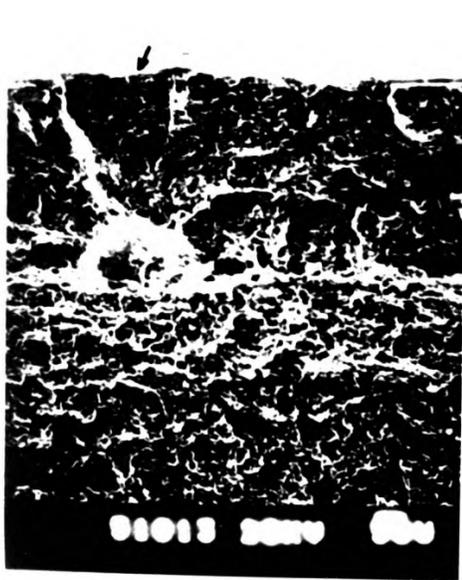
Typical (a) potential vs time and (c) corrosion current vs time curves for polished mild steel specimens in 1.0 M sodium chloride solution at 170 MPa, R=-1. The applied potential for (c) is -560 mV (SCE). (b) Fracture surface of a potential vs time (a) curve specimen after 30 minutes. Arrow indicates the presence of a pit from which a crack is seen to emanate.

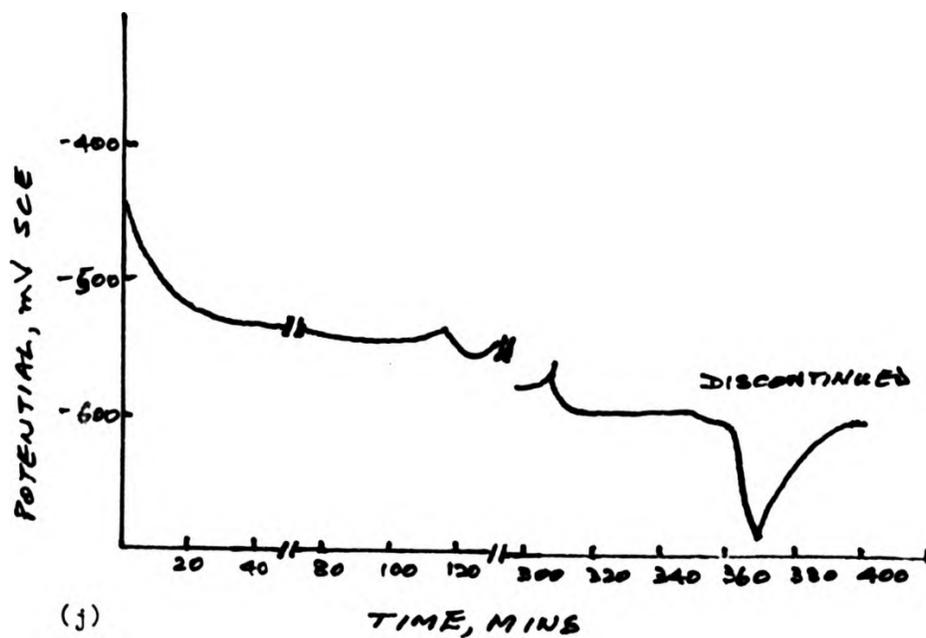
(h) Micrograph of the transverse surface (x 75) of a polished mild steel specimen at 277 MPa,  $R=-1$ , after  $8.36 \times 10^5$  reversals in 0.6 M sodium chloride solution exhibiting a crack emanating from a pit. Etch: 2% Nital. (j) Typical potential vs time curve for mill scaled specimen at 170 MPa,  $R=-1$ , in 0.6 M sodium chloride solution.

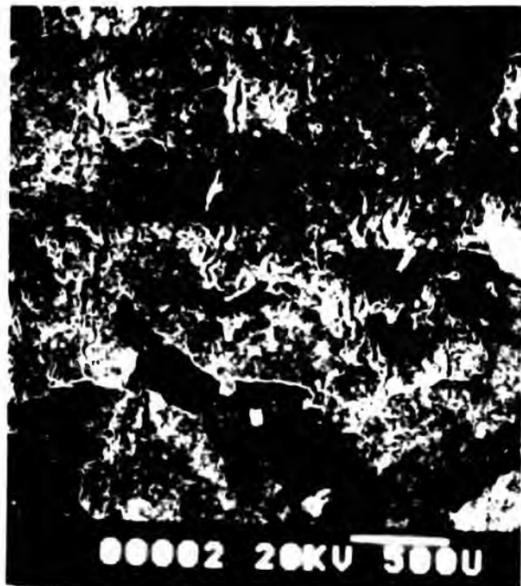
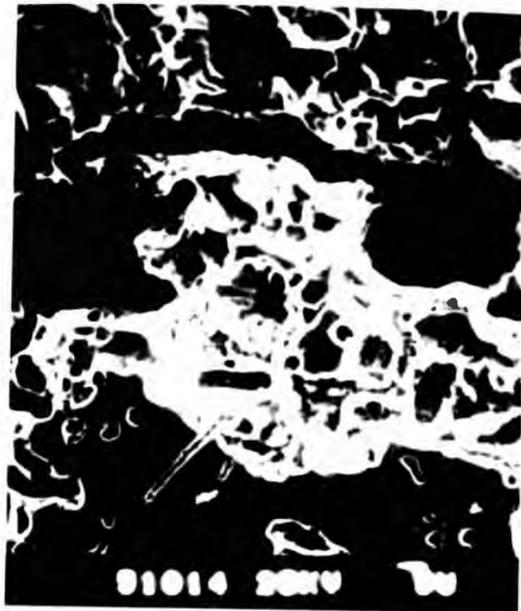
(k) (stress axis  $\rightarrow$ )

(l) (stress axis  $\downarrow$ )

Micrographs of the longitudinal surface of potential vs time (j) curve specimens after (k) 360 minutes exhibiting cracks and dissolution of the mill scale, and (l) 300 minutes showing joining of cracks. (m) Typical corrosion current vs time curve for mill scaled specimen at 170 MPa, R=-1, with an applied potential -440 mV (SCE).

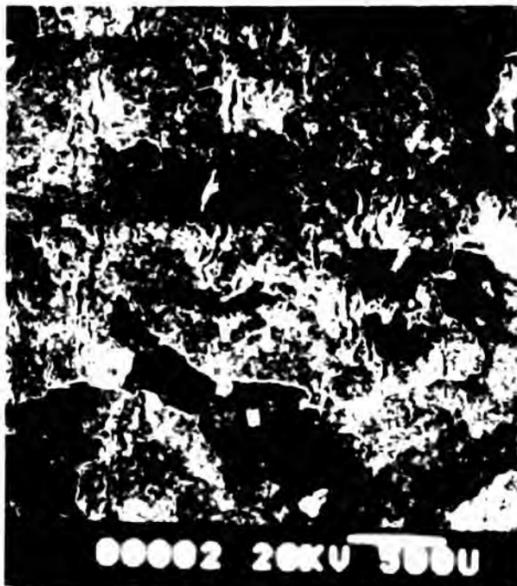
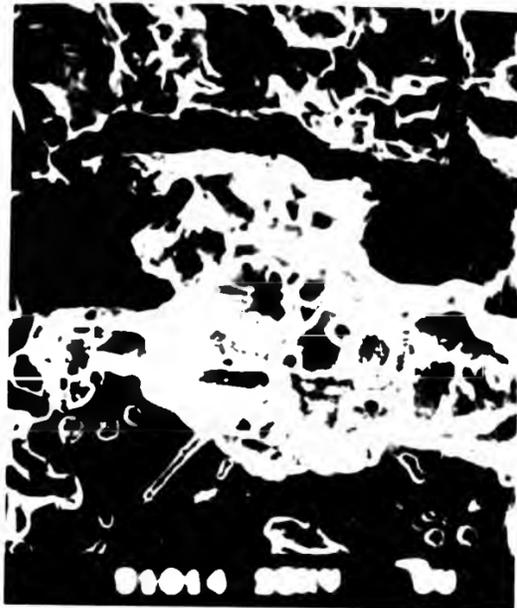
(k) Longitudinal surface of potential vs time curve specimens after (k) 350 minutes exhibiting cracks and dissolution of the mill scale, and (l) 300 minutes showing joining of cracks. (m) Typical corrosion current vs time curve for mill scaled specimen at 120 MPa, R=-1, with an applied potential -440 mV (SCE).

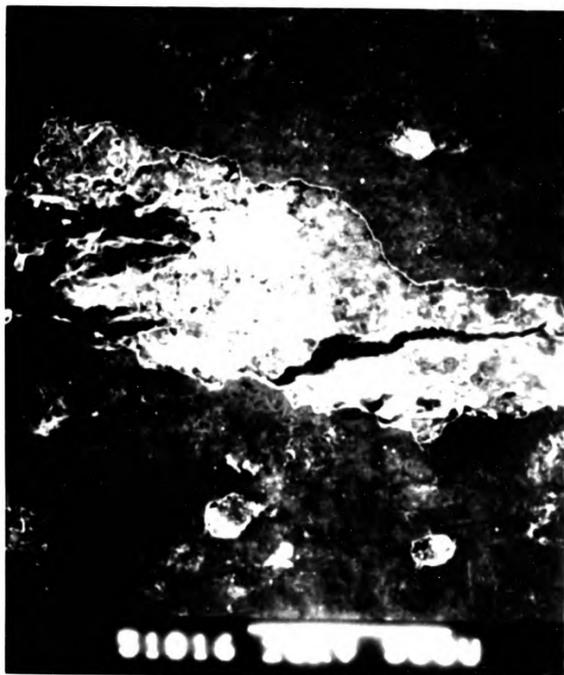
(n) ( stress axis  $\updownarrow$  )

Micrograph of the longitudinal surface of a corrosion current vs time (m) curve specimen after 240 minutes exhibiting dissolution of mill scale.

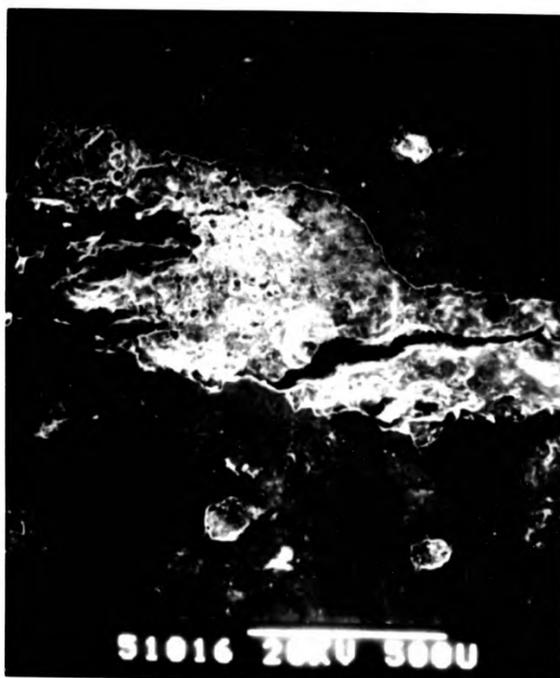
(n) ( stress axis ↑ )

Micrograph of the longitudinal surface of a corrosion current vs time (m) curve specimen after 240 minutes exhibiting dissolution of mill scale.

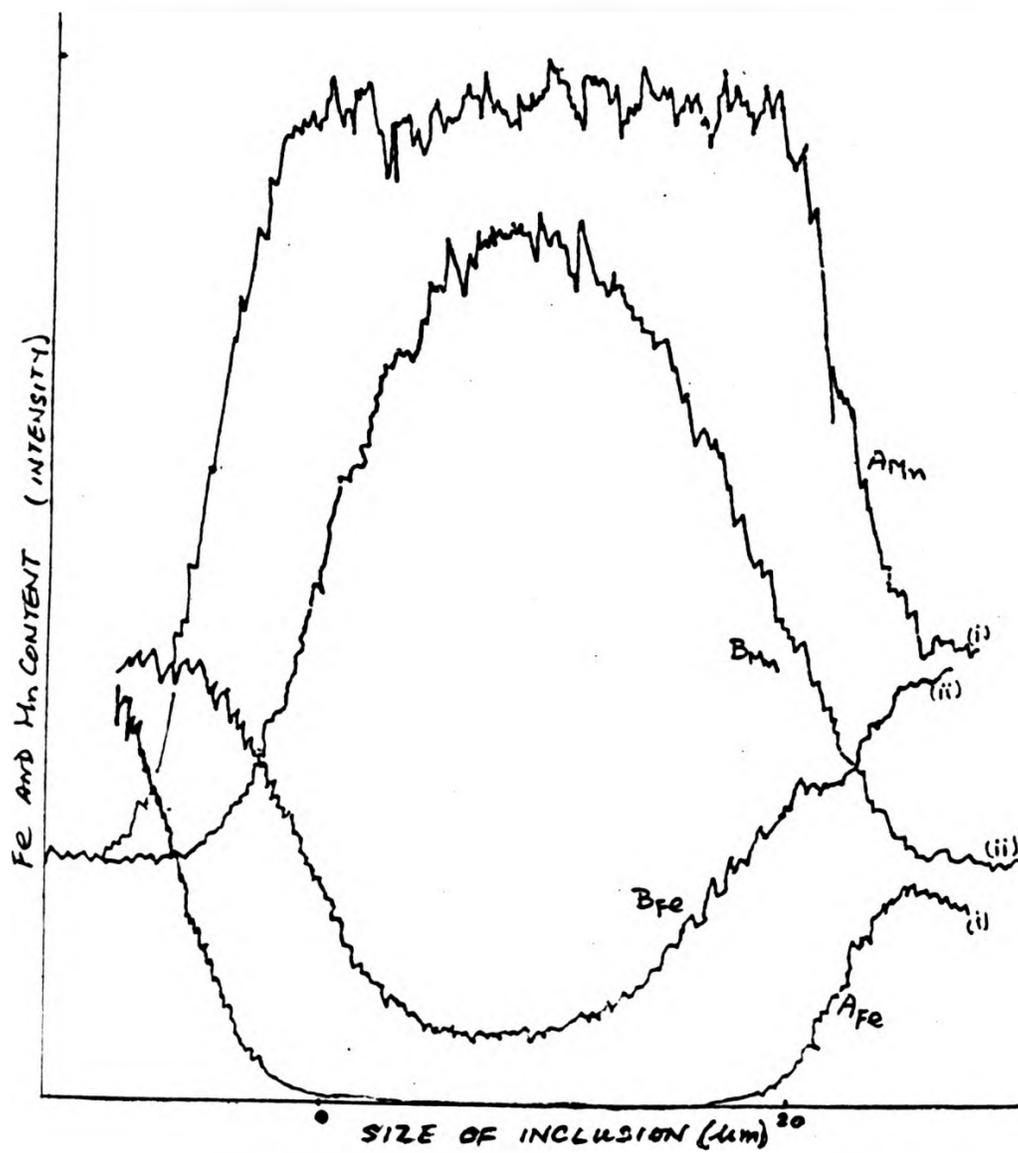
- (a) Electron probe microanalysis results of inclusions on wrought specimen surface prior to immersion test, exhibiting the presence of (i) only Mn (curve  $A_{Fe}-A_{Mn}$ ) and (ii) Fe and Mn (curve  $B_{Fe}-B_{Mn}$ ). It indicates that the presence of Fe in the inclusion reduces the Mn content.

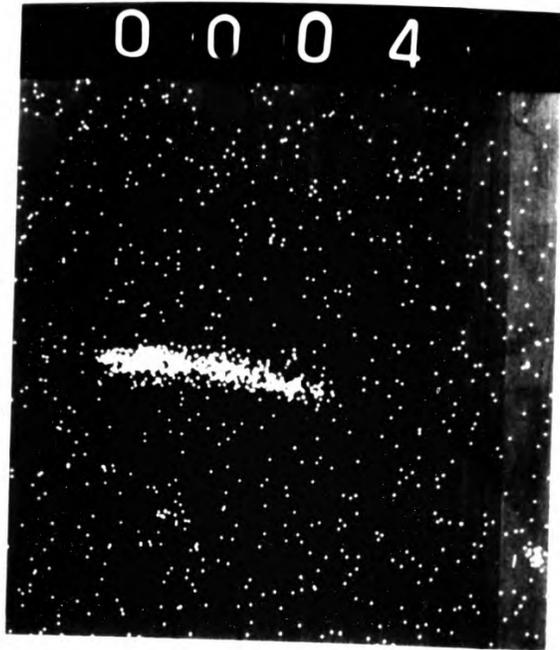
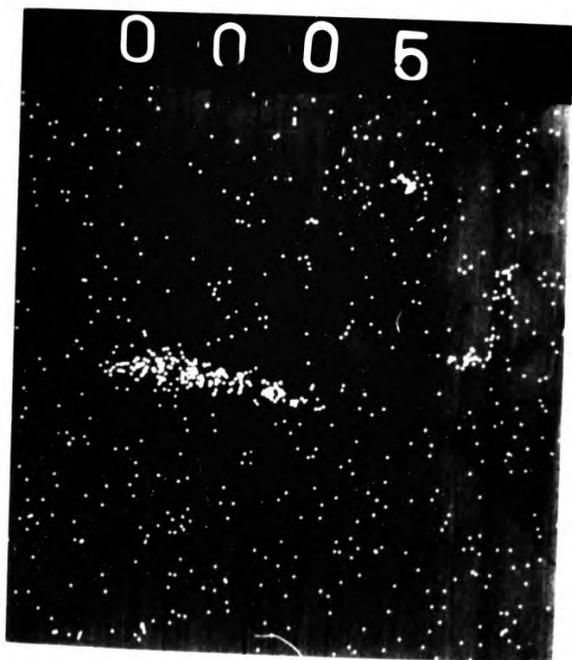
Electron probe microanalytic profile of a specimen  
on the surface of a specimen surface prior to etching,  
indicating presence of Al at approx. 10% wt.

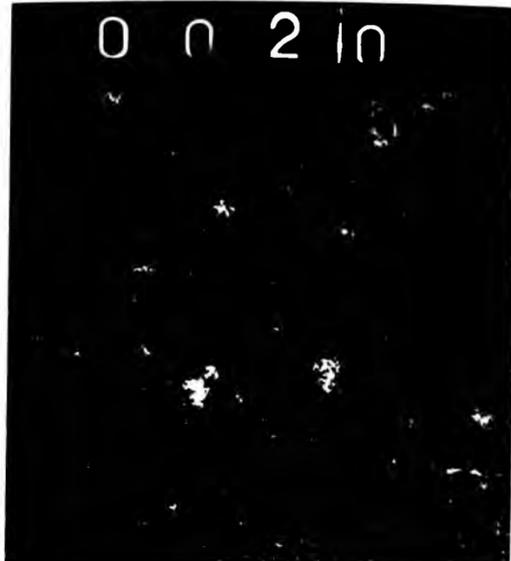
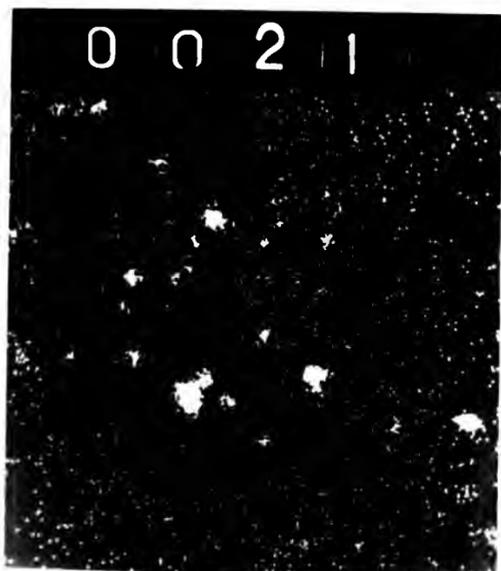
(c) Electron probe microanalysis results of wrought specimen surface showing (i) inclusions and indicating the presence of (ii) Mn and (iii) S, and the absence of (iv) Si after immersion in 0.6 M sodium chloride solution for 5 mins. x 600

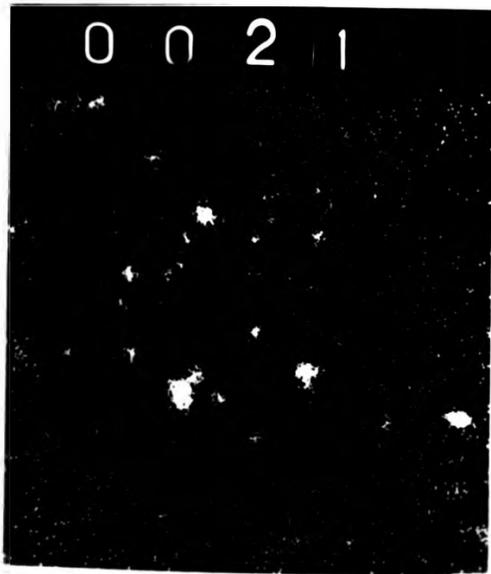
(c) Electron probe microanalysis results of wrought specimen surface showing (i) inclusions and indicating the presence of (ii) Mn and (iii) S, and the absence of (iv) Si after immersion in 0.6 M sodium chloride solution for 5 mins. x 600

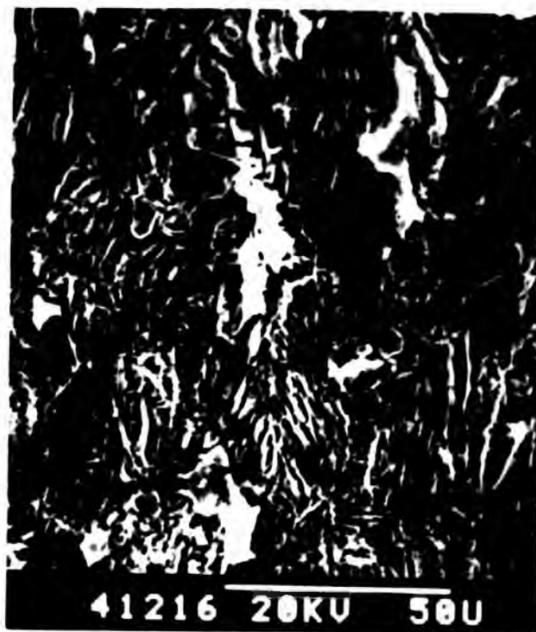
(a) (b) (c) (d)

Annealed specimens, 920°C for 3 hours in argon, (a) rotated without an applied stress after  $1.3 \times 10^6$  reversals showing high inclusion density area and (d) after 2000 reversals at 198 MPa exhibiting localised attack and breakdown of inclusions. Crystallographic pits are also observed. Wrought specimens (b) after 200 reversals at 183 MPa showing dissolution around some inclusions (surface shows presence of salt film) and (c) after 2000 reversals at 197 MPa exhibiting localised attack at inclusions.

Fig. 11: Rotating bend fatigue tests at 47 Hz, R=-1.

On application of stress (183 MPa) dissolution at the inclusion - matrix interface was found to occur (Figure R 11b). Some of the inclusions also appear to have dissolved; the micrograph shows a region of high inclusion density. A similar result was also observed for a specimen tested at 197 MPa for 2,000 reversals (Figure R 11c). The region shown consists of elongated as well as a "shower" of smaller sulphide particles. The commencement of dissolution of these inclusions is shown in Figure R 11d.

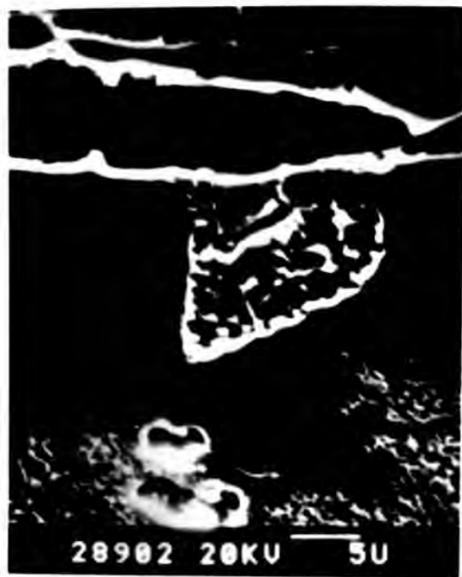
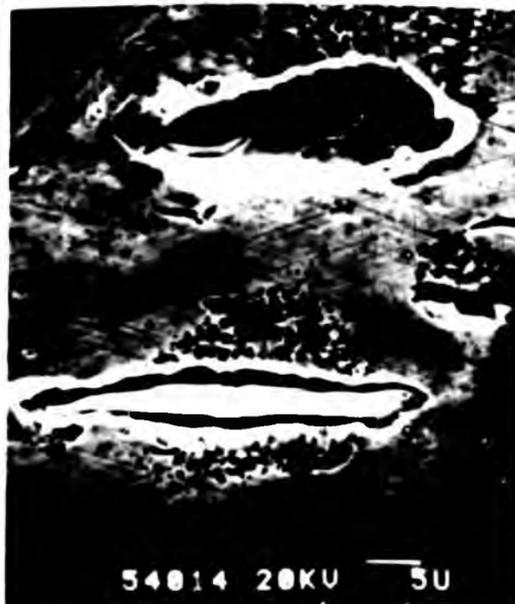
Fig. 11: Rotating bend fatigue tests at 47 Hz, R=-1.

rough specimens after (e)  $6.1 \times 10^3$  reversals showing dissolution of ferrite in pearlitic area associated with an inclusion, (f)  $3.4 \times 10^4$  reversals showing localised corrosion in the vicinity of an inclusion, (g)  $7.5 \times 10^4$  reversals indicating coalescence of micropits in the ligaments between the inclusions in a high inclusion density region, and (h)  $1.06 \times 10^5$  reversals exhibiting localised attack around an inclusion. Stress = 193 MPa.

Increasing the duration of the tests led to the dissolution of ferrite in the pearlitic area in addition to the dissolution in and around the inclusions (Figure R 11e). A further increase in the number of reversals at the same stress reveals localised corrosion at the matrix - inclusion interface leaving the inclusion isolated from the matrix. Localised corrosion also occurs in the vicinity of the inclusion creating micropits (Figure R 11f). Figure R 11g shows the tendency of these micropits in the ligaments between the sulphide particles in a high inclusion density region to coalesce. In the low density regions in which the inclusions are further apart, the tendency for amalgamation of the micro or macropits is not so discernible (Figure R 11h).

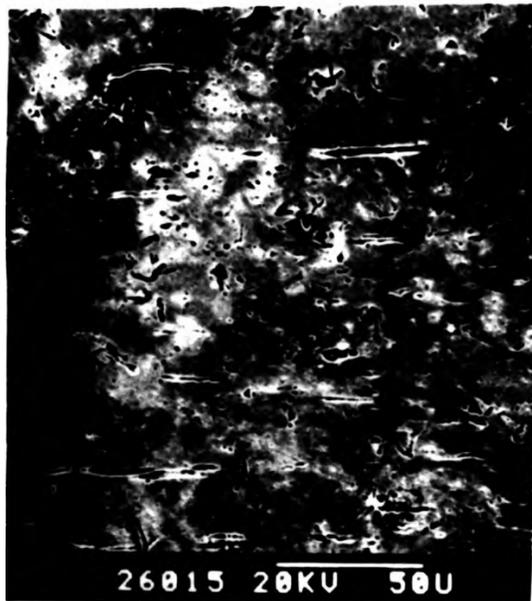
Wrought specimens after (l) 2000 reversals showing inclusions in the relatively low inclusion density region, (m) 2000 reversals exhibiting coalescence of the micropits, dissolution of the inclusions, and linking up of the macropits, (n) 3000 reversals showing dissolution of inclusions, and (p)  $3.4 \times 10^4$  reversals indicating absence of macropit linking in the low inclusion density region. Stress = 278 MPa.
