Some Aspects of Crack Initiation in Mild Steel Subjected to  
Fatigue Stressing in a Corrosive Environment

G P Ray BSc MSc CEng MIM MICorrT MIMF

A report presented in partial fulfilment of the requirements  
of the PhD Degree of COUNCIL OF NATIONAL ACADEMIC AWARDS.

City of London Polytechnic  
Sir John Cass School of Science  
and Technology  
Department of Metallurgy and Materials  
LONDON

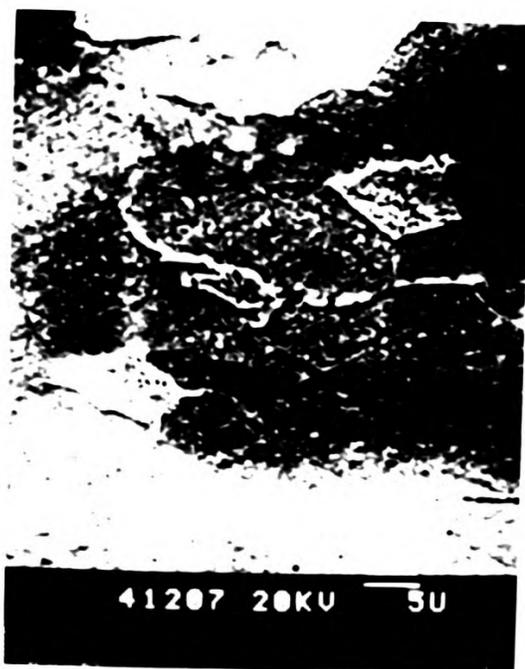
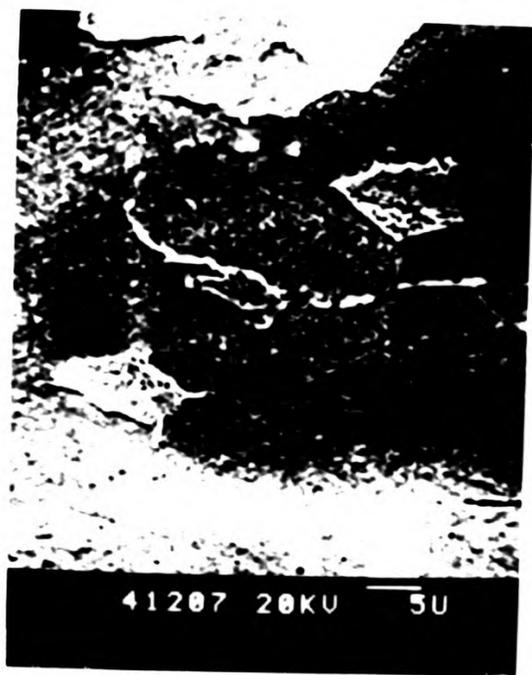
(u)

Wrought specimen after 2000 reversals at 309 MPa showing dissolution along grain boundaries and in pearlitic areas.

When the stress is further increased to 309 MPa dissolution is found to occur at the grain boundaries and in the pearlitic areas after  $2 \times 10^3$  reversals resulting in the formation of pits (Figure R 11u).

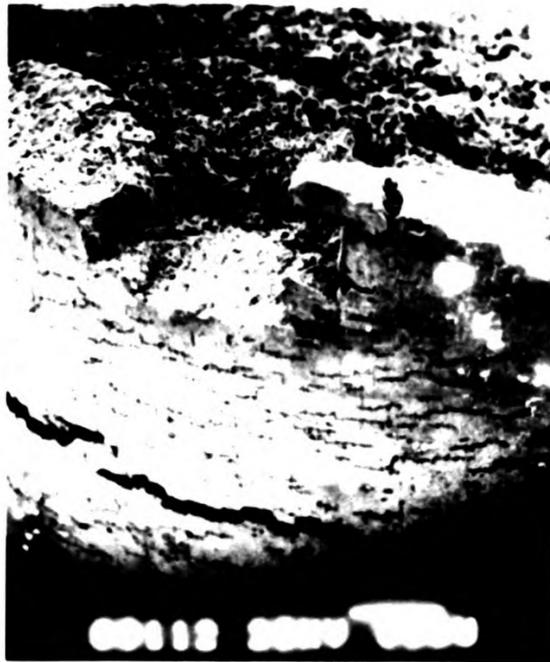
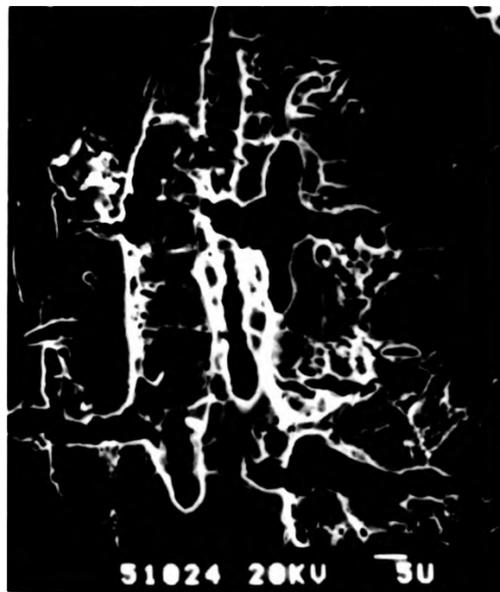
Fig. 9.11: Rotating bend fatigue tests at 47 Hz, R=-1.

Wrought specimens (v) after  $1.61 \times 10^5$  reversals at 364 MPa indicating (i) the importance of mechanical factor at higher stresses and (ii) the linking of transverse cracks leading to fracture; after (w)  $1.01 \times 10^6$  reversals at 247 MPa exhibiting the close relationship between surface longitudinal and transverse cracks associated with (i) inclusions and (ii) formation of macropits.

At this high stress level, all the phenomena, such as the dissolution and detachment of the inclusions, formation of hexagonal pits, linking up of the micropits to create incipient cracks in the transverse direction, are observed. However, the significance of dissolution appears to decrease and that of the stress appear to be predominant in the mechanism of the formation of incipient cracks thereby reducing the number of reversals required to nucleate microcracks. The close relationship between the inclusions and the formation of transverse cracks is shown in Figures R 11v and R 11w.

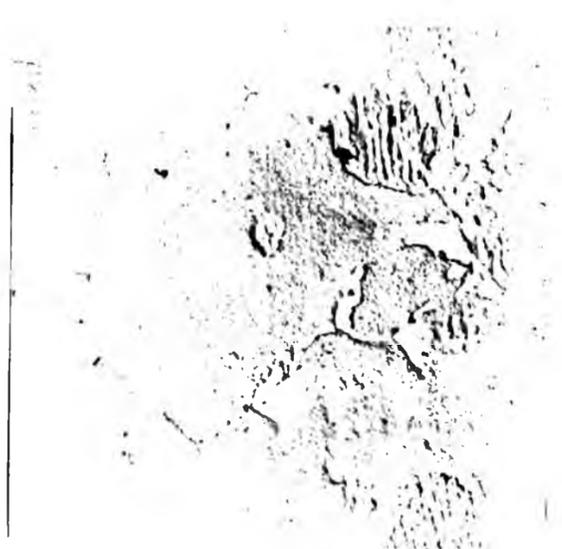
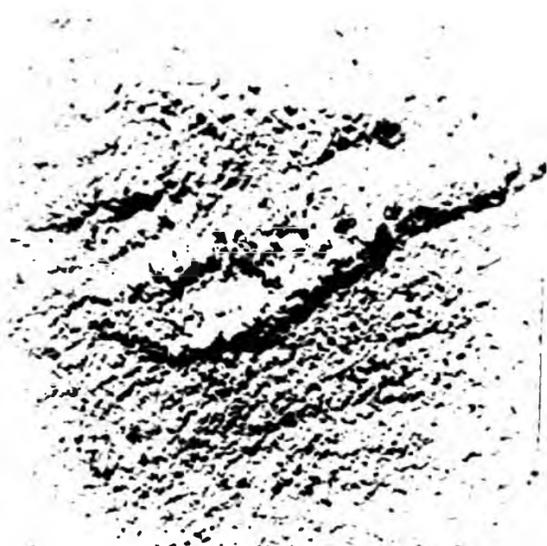
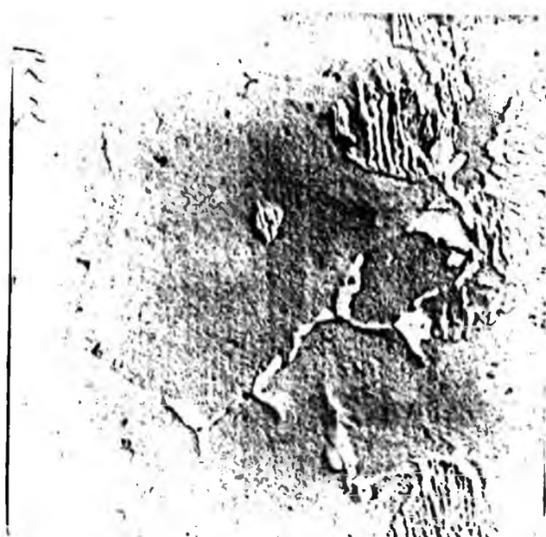
(d) Preferential attack at the inclusions, x 2182, immersion for nearly 17 hours, (e) higher magnification of (d), x 9727, indicating attack at the interfaces, and (f) localised attack at the cementite-ferrite interface, micropits at the grain boundaries, and terminations and bends in the lamellar structure, x 2182, immersion for nearly 17 hours.

Figure R 12 exhibits the surface of the specimen after 5 and approximately 17 hours immersion in 0.6 M sodium chloride solution indicating dissolution of the inclusions and the matrix - inclusion interfaces (Figures R 12a - R 12f). Figure R 12g shows localised attack at the cementite - ferrite interfaces, micropits at the grain boundaries, and terminations and bends in the lamellar structures.

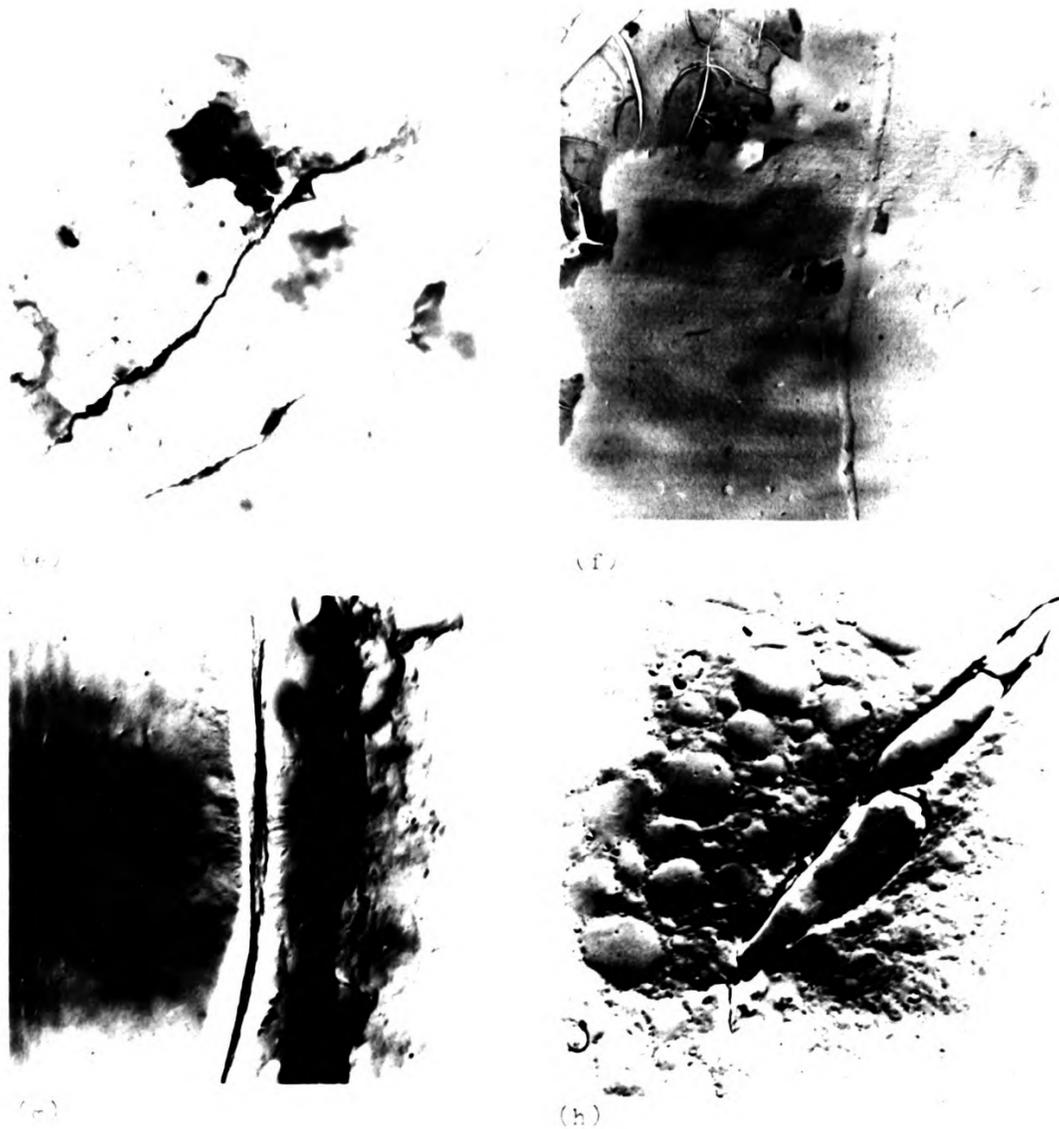
Wrought specimens exhibiting (e) formation of microfissure in the transverse direction from an inclusion after  $3.18 \times 10^5$  reversals, x 4900, (f) slip band formation after  $3.18 \times 10^5$  reversals, x 3091, (g) slip band and associated microfissures after  $4.16 \times 10^5$  reversals, x 9727, and (h) localised attack around an inclusion after  $4.16 \times 10^5$  reversals, x 9727.

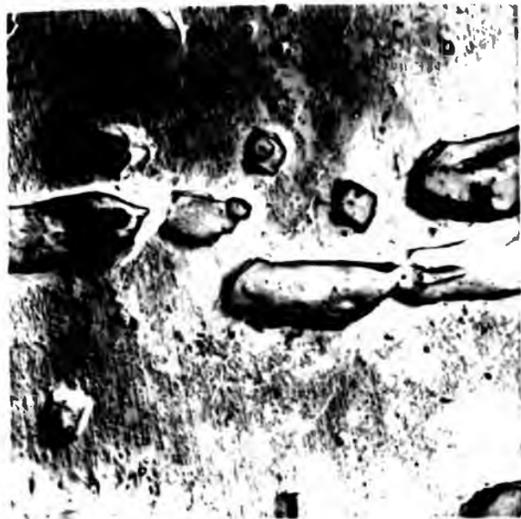
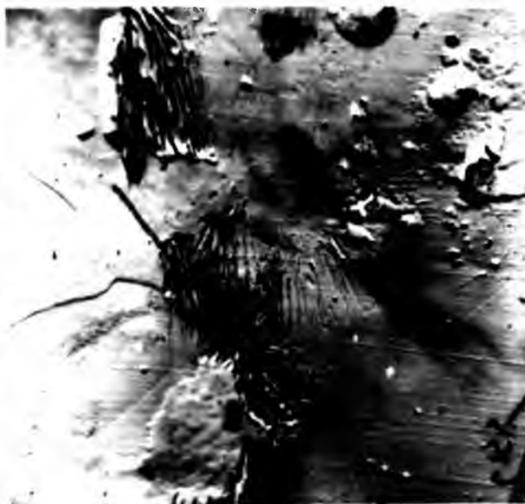
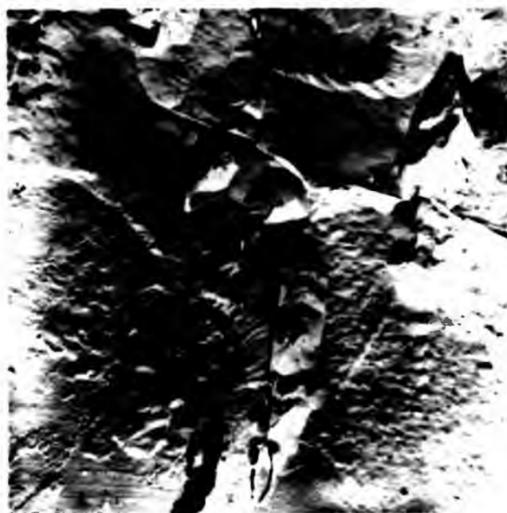
Fig. 14: Transmission electron micrographs of rotating bend fatigue tested specimens at 95 MPa,  $R=-1$ , 47 Hz.

Annealed specimens exhibiting (a) localised attack at the matrix-inclusion interface and rectangular pits after  $8.7 \times 10^4$  reversals  $\times 2182$ , (b) voids in pearlitic region after  $6.26 \times 10^5$  reversals  $\times 2182$ , (c) higher magnification of (b) indicating bends and terminations,  $\times 11273$ , and (d) extrusion-intrusion type feature at triple point after  $6.25 \times 10^5$  reversals,  $\times 2182$ .

Localised attack at the ferrite - cementite interfaces, and terminations and bends in the cementite lamellae in the pearlitic region are found to occur (Figures R 14b and R 14c). Although these defects, such as bands and terminations of the cementite lamellae, have been observed in specimens with zero stress, they appear to become more prominent on the application of cyclic stresses.

Figure R 14d shows features resembling extrusion - intrusion effects associated with microcracks at triple points after  $6.25 \times 10^5$  reversals. With increasing number of reversals, coalescence of the microcracks in the ferrite of pearlitic regions is found to occur (Figure R 14e). Inclusions associated with blisters and intrusions are also observed (Figure R 14f). A deformed region containing etch pits is illustrated in Figures R 14g and R 14h. Figures R 14j - R 14m show microcracks and slip bands at grain boundaries and at the junction of the grain boundaries; these microcracks and slip bands appear to play a significant role with further increase in the number of reversals (Figures R 14n - R 14q).

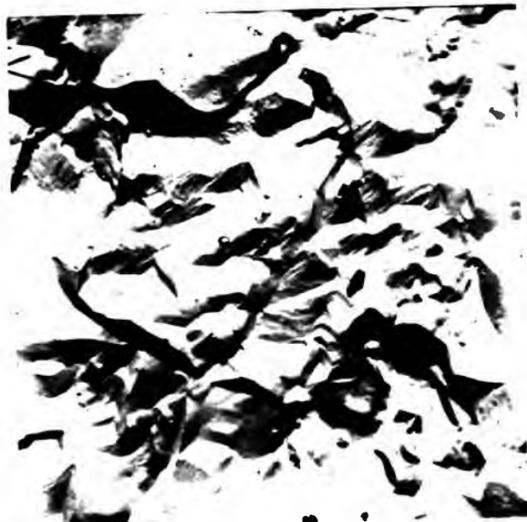
Annealed specimens exhibiting (e) linking up of microbits to form microcracks in pearlitic regions after  $1.05 \times 10^6$  reversals,  $\times 11273$ , (f) inclusions with features resembling blisters and intrusions after  $1.05 \times 10^6$  reversals,  $\times 11273$ , (g) inhomogeneous deformation on the surface resulting in microcrack formation after  $1.05 \times 10^6$  reversals,  $\times 2187$ , and (h) a chain of etch pits in the deformed area in (g),  $\times 8187$ .

Fig. 14: Transmission electron micrographs of rotating bend fatigue tested specimens at 950 Ma,  $\sigma = 1, 47$  Hz.

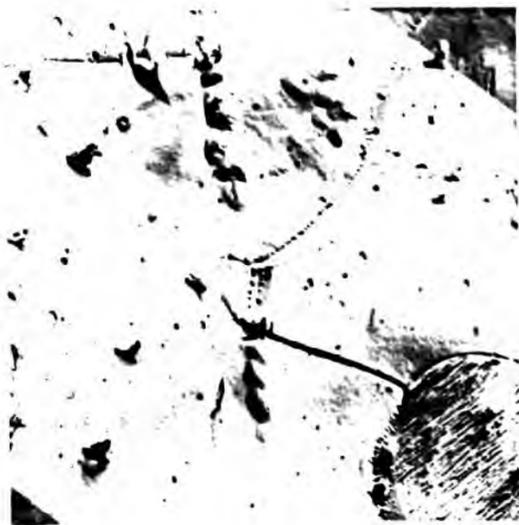
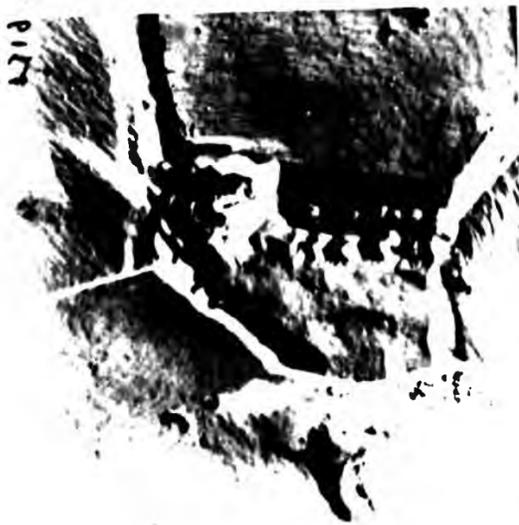
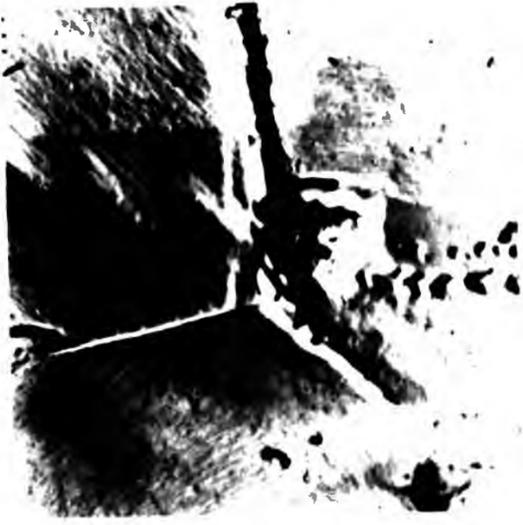
Uncoiled specimens exhibiting (j) subgrain formation at grain boundary junction, slip bands near grain boundary and microcrack formation after  $1.05 \times 10^6$  reversals, 2182, (k) higher magnification of the slipped region near grain boundary, x 4908, (l) etch pits and subgrain at the grain boundary junction in (j), x 918, and (m) microcrack formation at the grain boundary junction, x 2182.

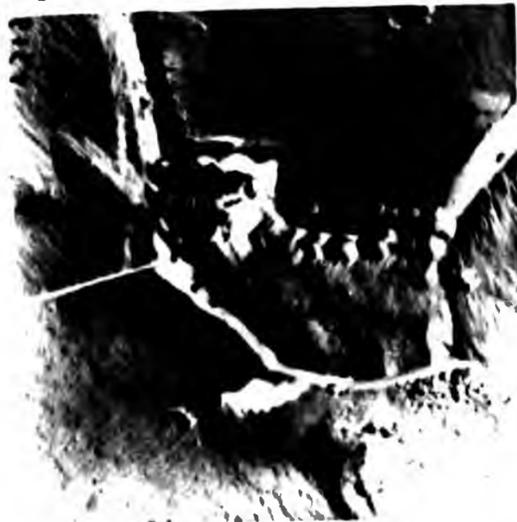
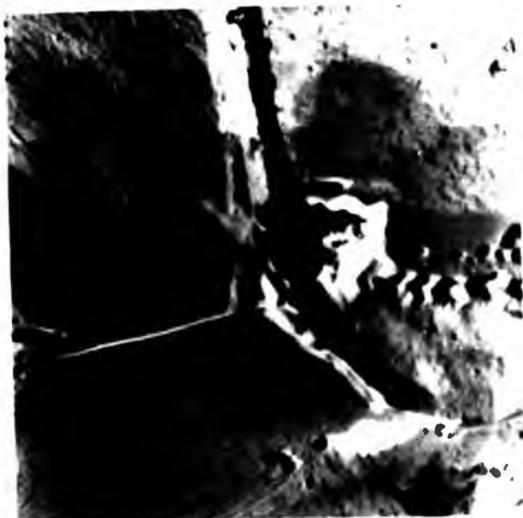
Annealed specimens exhibiting (j) subgrain formation at grain boundary junctions, slip bands near grain boundary and microcrack formation after  $1.05 \times 10^6$  reversals, 2182, (k) higher magnification of the slipped region near grain boundary, x 4908, (l) etch pits and subgrain at the grain boundary junction in (j), x 8182, and (m) microcrack formation at the grain boundary junction, x 8182.

Fig R 14: Transmission electron micrographs of rotating bend fatigue tested specimens at 95 MPa,  $R=-1$ , 47 Hz.

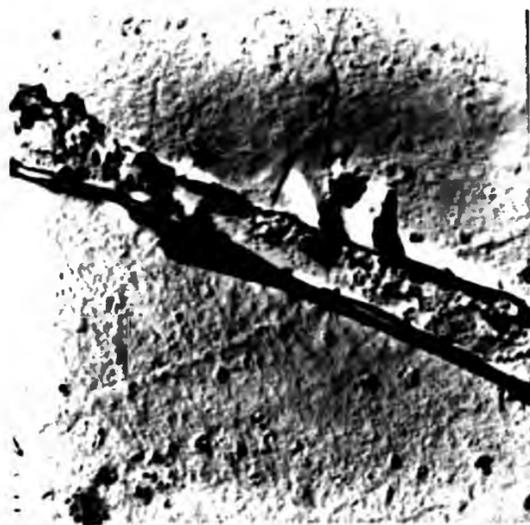
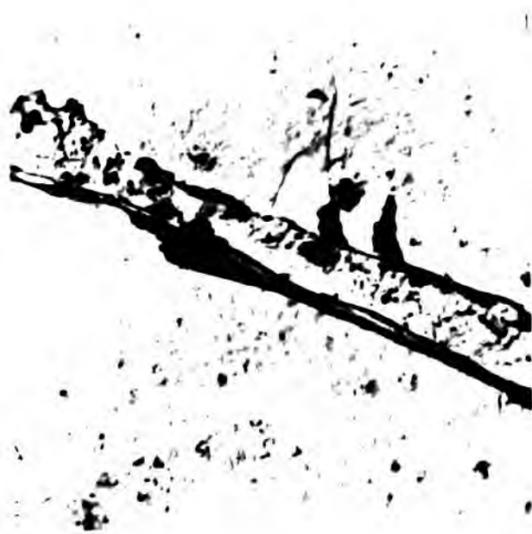
Wrought specimens after 2000 reversals showing (a) dissolution of the inclusion and at the matrix-inclusion interface; incipient crack formation is also indicated; x 11273, (b) slip band and blister formation, x 20455, (c) blisters with microcracks and pin holes (area adjacent to (b)), and (d) a pearlitic region; the lamellar structure contains terminations and bends; dissolution at the ferrite-cementite interface and microvoids in the ferrite matrix are also observed; x 20455

Fig. R 15: Transmission electron micrographs of rotating bend fatigue tested specimens at 193 MPa,  $R=-1$ , 47 Hz.

Figure R 15a - R 15c illustrate dissolution at the matrix - inclusion interface after  $2 \times 10^3$  reversals at 193 MPa,  $R = -1$ . Blisters associated with the inclusions are also observed. Figure R 15d shows dissolution at the ferrite - cementite interface and microvoid formation in ferrite of pearlite. With increasing number of reversals, dissolution of inclusions appears to occur (Figure R 15e). Microvoids also appear in slip bands after  $6.1 \times 10^3$  reversals (Figure R 15f) and Figure R 15g shows the formation of micropits at sub-boundaries. Linking of microvoids in pearlite regions are observed after  $7.5 \times 10^4$  reversals (Figures R 15h and R 15j). Coalescence of micropits in slip bands and around inclusions, and nucleation of microcracks in slip band are shown in Figures R 15k - R 15m.

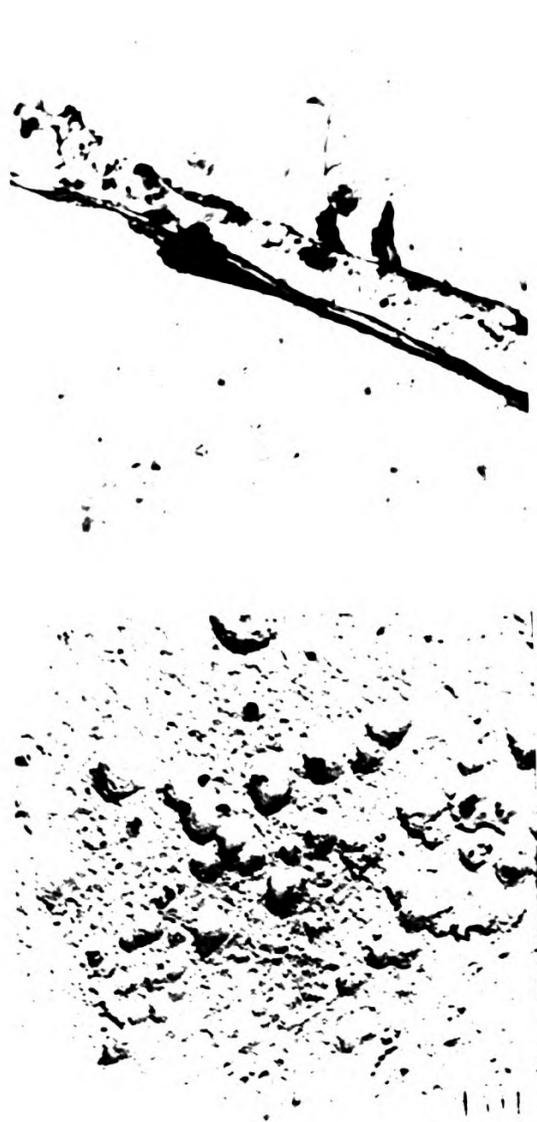
Wrought specimens exhibiting (e) dissolution of an inclusion after 6100 reversals, x 9727, (f) slip band formation with microcracks outlining the band after 6100 reversals, x 9727, (g) surface rumplings and formation and linking of micropits indicating sub-boundaries after  $3.4 \times 10^4$  reversals, x 11273, and (h) coalescence of microvoids in pearlitic area after  $7.47 \times 10^4$  reversals, 2182.

FIG. 15: Transmission electron micrographs of rotating bend fatigue tested specimens at 103 MPa, R=-1, 47 Hz.

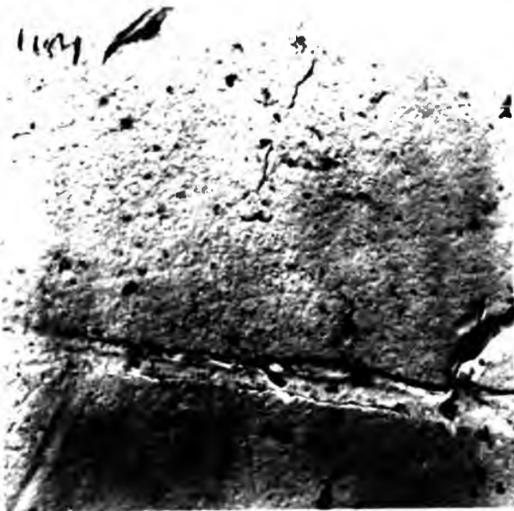
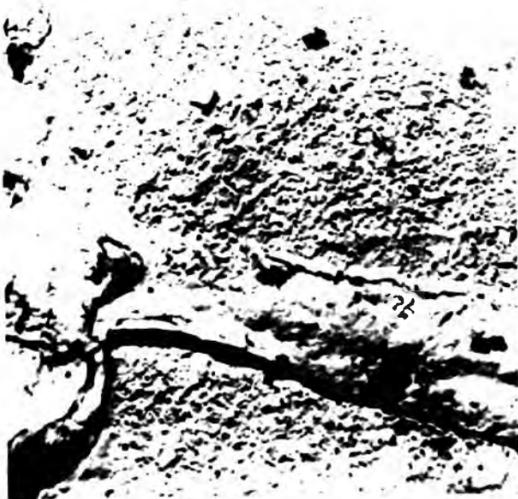
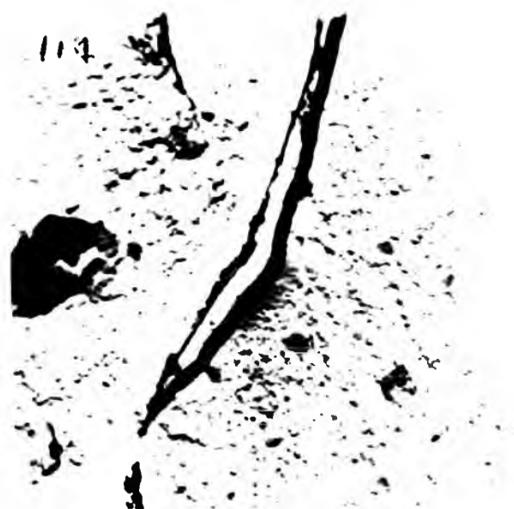
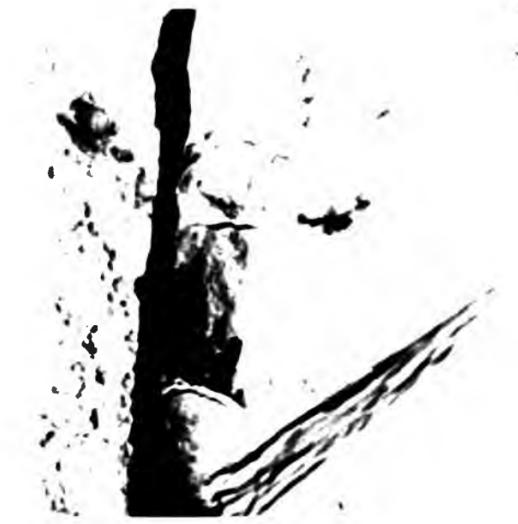
Fig. R 17: Transmission electron micrographs of rotating bend fatigue tested specimens at 278 MPa, R=-1, 47 Hz.

rought specimens exhibiting (a) slip band with microvoid, between an inclusion and pearlitic region (not shown in the micrograph), x 4909, (b) higher magnification of (a), x 20455, (c) dissolution of an inclusion and at matrix-inclusion interface, x 20455, and (d) dissolution at matrix-inclusion interface and transverse microcracks in the region immediately adjacent to the interface, x 40000. After 2000 reversals.

Formation of slip bands have been observed after  $2 \times 10^3$  reversals at 278 MPa,  $R = -1$  (Figure R 17a). Microvoids also tend to form at the slip bands (Figure R 17b). Dissolution of the inclusions and that at the matrix - inclusion interface appear to be somewhat more rapid at the higher stress range (Figure R 17c) than at the lower one.

Localised corrosion at the matrix - inclusion interface is found to occur leaving the inclusion isolated from the matrix (Figure R 17c). Closer examination of the interfaces of some of the inclusions reveals the nucleation of transverse microcracks due to the coalescence of the micropits in the region close to the interface (Figure R 17d). That this region is contaminated with S has been shown in Figure R 11k. Dissolution at the ferrite - cementite interface is shown in Figure R 17e whilst Figure R 17f shows the formation of a microfissure.

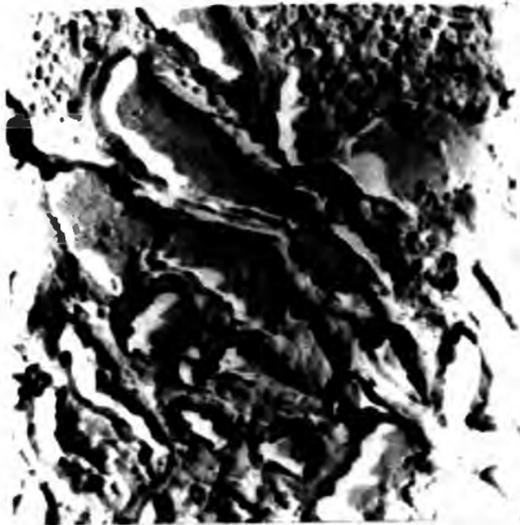
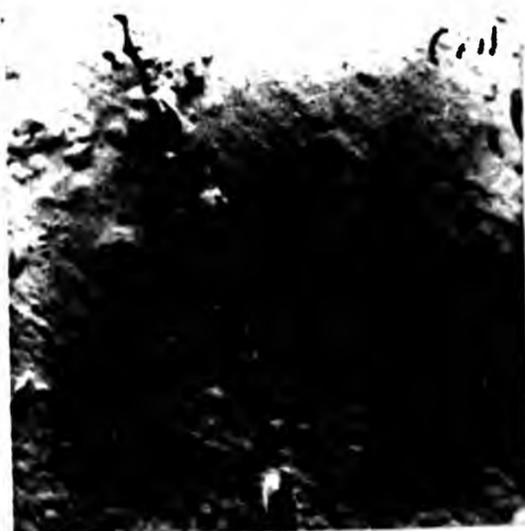
Fig R 17: Transmission electron micrographs of rotating bend fatigue tested specimens at 278 MPa, R=-1, 47 Hz.

rought specimens exhibiting (e) dissolution at the ferrite-cementite interface resulting in the formation of microfissure after 2000 reversals, x 40000, (f) formation of microcrack after 2000 reversals, x 20000, (g) inclusions with features resembling blisters after 3000 reversals, x 30182, and (h) slip bands near an inclusion after 3000 reversals, x 16273.

Increasing the number of reversals at the same stress reveals blisters associated with inclusions (Figure R 17g), slip bands near a fractured inclusion (Figure R 17h) and a deformed region adjacent to an inclusion (Figure R 17j). This region appears to contain microfissures. Figure R 17k shows that the region immediately adjacent to the inclusions contain micropits and slip bands. Features resembling intrusions are also observed in the slip bands (Figure R 17l).

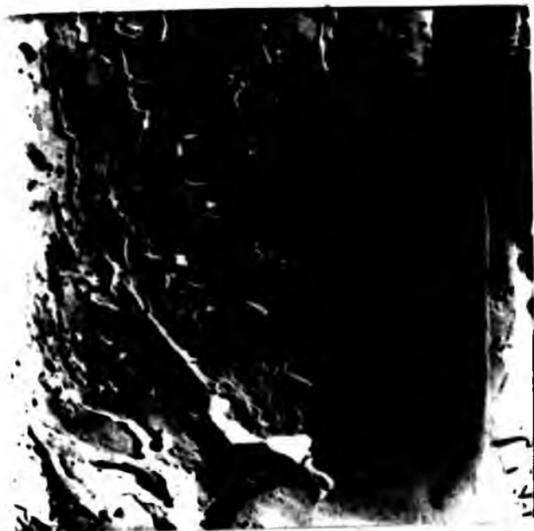
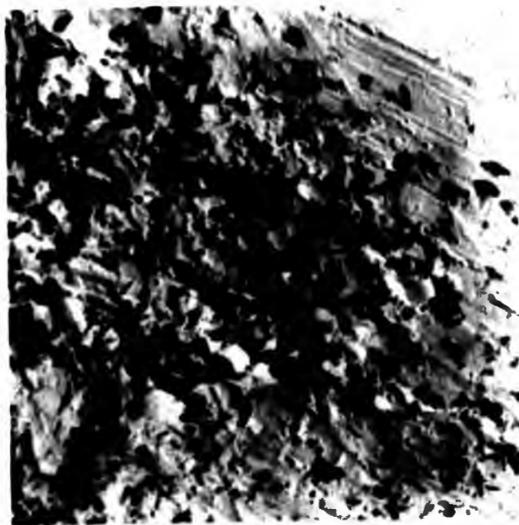
Fig R 17: Transmission electron micrographs of rotating bend fatigue tested specimens at 278 MPa,  $R=-1$ , 47 Hz.

Wrought specimens exhibiting (e) dissolution at the ferrite-cementite interface resulting in the formation of microfissure after 2000 reversals,  $\times 40000$ , (f) formation of microcrack after 2000 reversals,  $\times 20000$ , (g) inclusions with features resembling blisters after 3000 reversals,  $\times 30182$ , and (h) slip bands near an inclusion after 3000 reversals,  $\times 16273$ .

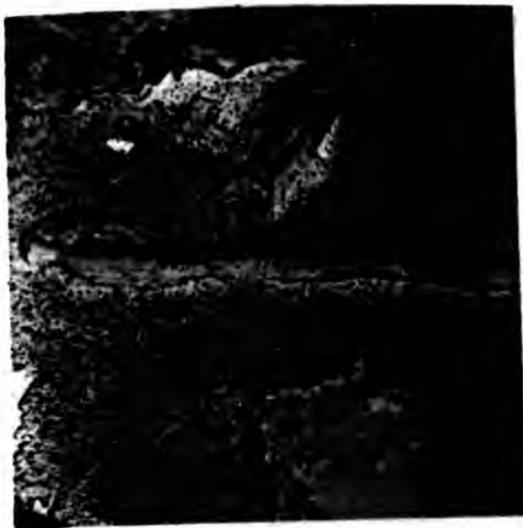
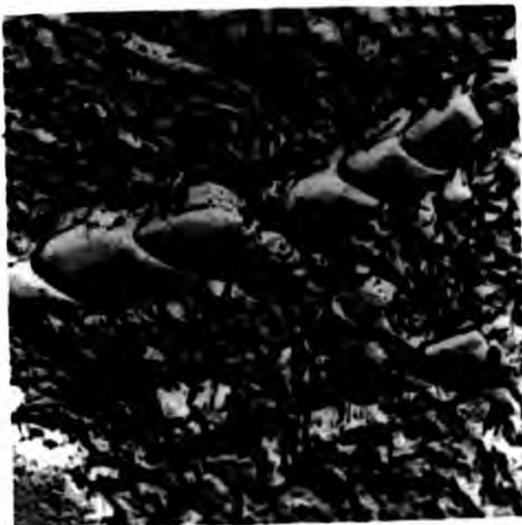
Wrought specimens exhibiting (m) dissolution at the matrix-inclusion interface, x 2132, (n) higher magnification of (m) indicating deformation of the inclusion, x 9727, (p) deformation and fracture of the inclusion, x 9727, and (q) dissolution of the ferrite in pearlitic region, x 9727. After  $3.4 \times 10^4$  reversals.

The effect of increasing the number of reversals to  $3.4 \times 10^4$  for the high density regions and that in the pearlitic sites are shown in Figures R 17m - R 17p and in R 17q respectively. Formation of slip bands between the pearlitic zones is also observed (Figure R 17r). Localised attack around spherical and elongated inclusions are shown in Figures R 17s and R 17t. It has been observed that the presence of inclusions on the slip band path tend to arrest its passage at  $5.1 \times 10^4$  reversals (Figure R 17t).

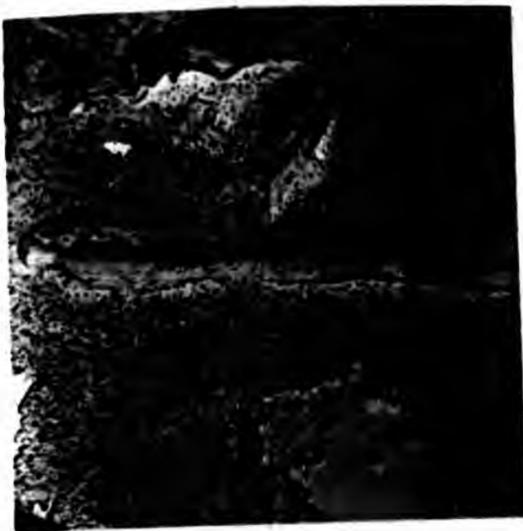
Fig R 17: Transmission electron micrographs of rotating bend fatigue tested specimens at 278 MPa, R=-1, 47 Hz.

Wrought specimens exhibiting (m) dissolution at the matrix-inclusion interface, x 2132, (n) higher magnification of (m) indicating deformation of the inclusion, x 9727, (p) deformation and fracture of the inclusion, x 9727, and (q) dissolution of the ferrite in pearlitic region, x 9727. After  $3.4 \times 10^4$  reversals.

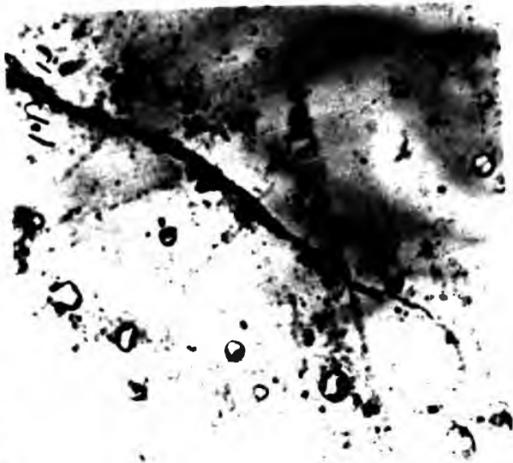
brought specimens exhibiting (r) slip band between two pearlitic regions after  $3.4 \times 10^4$  reversals,  $\times 2037$ , (s) dissolution around a spherical inclusion after  $5.11 \times 10^4$  reversals,  $\times 2037$ , (t) dissolution around a longitudinal inclusion and slip bands adjacent to the interface after  $5.11 \times 10^4$  reversals,  $\times 2037$ , and (u) formation of microcrack in the transverse direction after  $3.4 \times 10^4$  reversals,  $\times 8192$ .

Further increase in the test duration exhibits nucleation of microcracks in the transverse direction, from the matrix - inclusion interface (Figure R 17u). Slip bands near grain boundaries, dissolution of the inclusions in the high inclusion density region, and dissolution of ferrite in pearlite are observed at around  $4.38 \times 10^5$  reversals (Figures R 17v - R 17x).

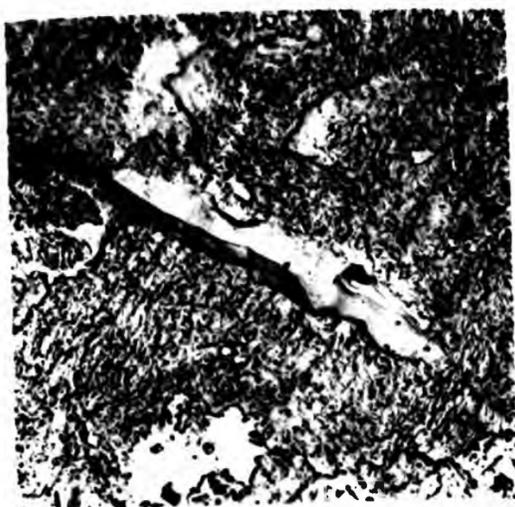
Wrought specimens exhibiting (r) slip band between two pearlitic regions after  $3.4 \times 10^4$  reversals,  $\times 2182$ , (s) dissolution around a spherical inclusion after  $5.11 \times 10^4$  reversals,  $\times 2182$ , (t) dissolution around a longitudinal inclusion and slip bands adjacent to the interface after  $5.11 \times 10^4$  reversals, 9727, and (u) formation of microcrack in the transverse direction after  $9.6 \times 10^4$  reversals,  $\times 8182$ .

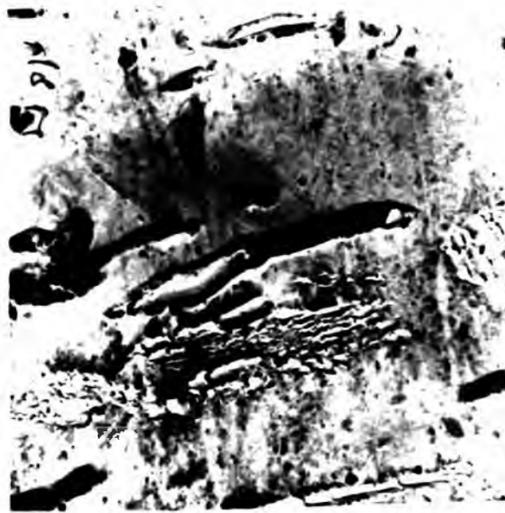
Fig R 17: Transmission electron micrographs of rotating bend fatigue tested specimens at 278 MPa,  $R=-1$ , 47 Hz.

Wrought specimens exhibiting (v) slip bands near grain boundaries,  $\times 2182$ , (w) high inclusion density region,  $\times 2182$ , and (x) dissolution of ferrite in pearlitic area,  $\times 11273$ . After  $4.39 \times 10^5$  reversals.

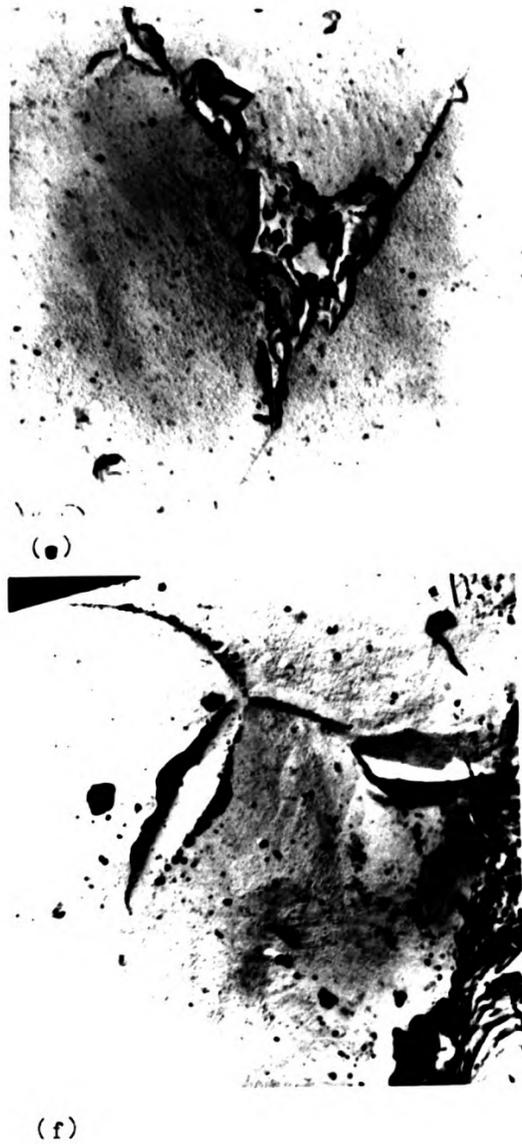
Wrought specimens exhibiting (e) linking up of microcracks at triple points after  $1.85 \times 10^6$  reversals,  $\times 11273$ , and (f) features resembling intrusions near triple point after  $1.85 \times 10^6$  reversals,  $\times 8182$ .

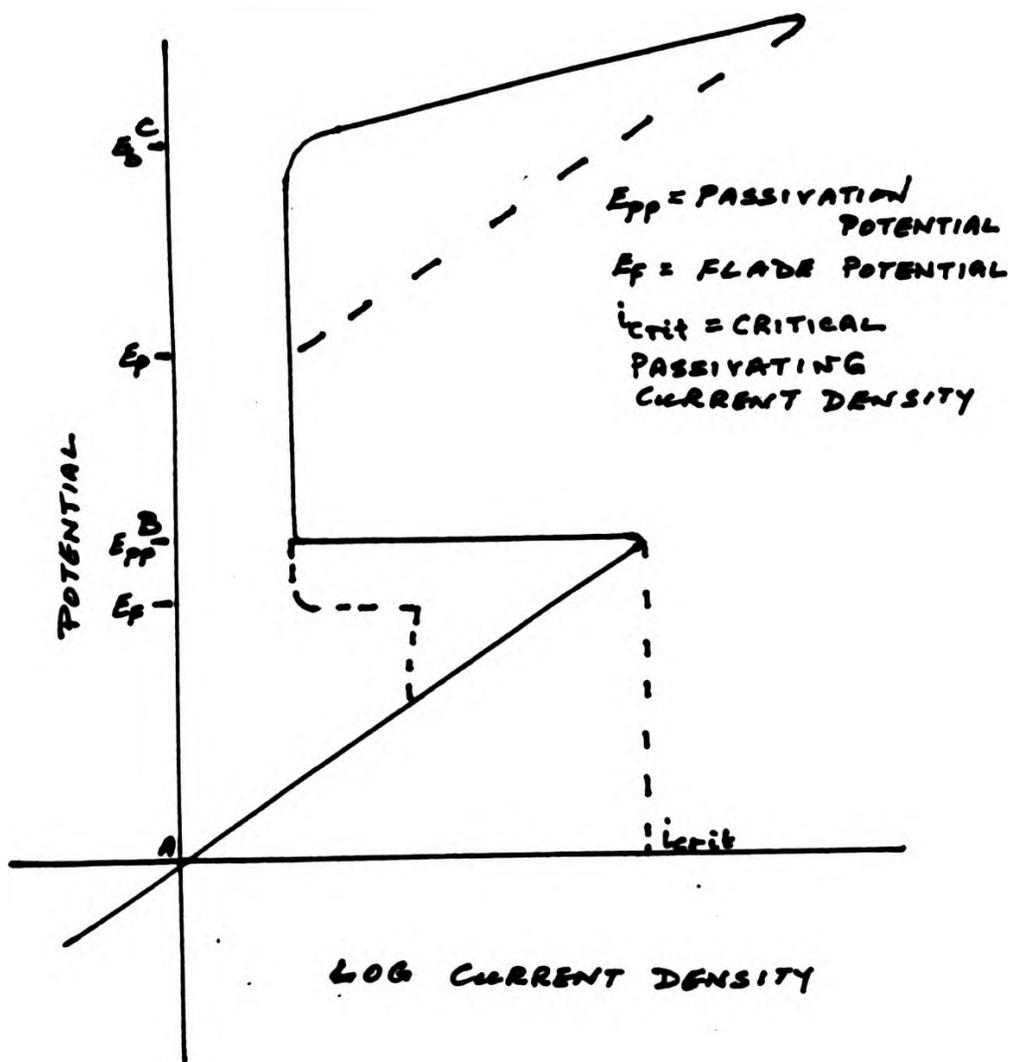
Fig D 1: Schematic potentiokinetic polarisation curve exhibiting active-passive transition.

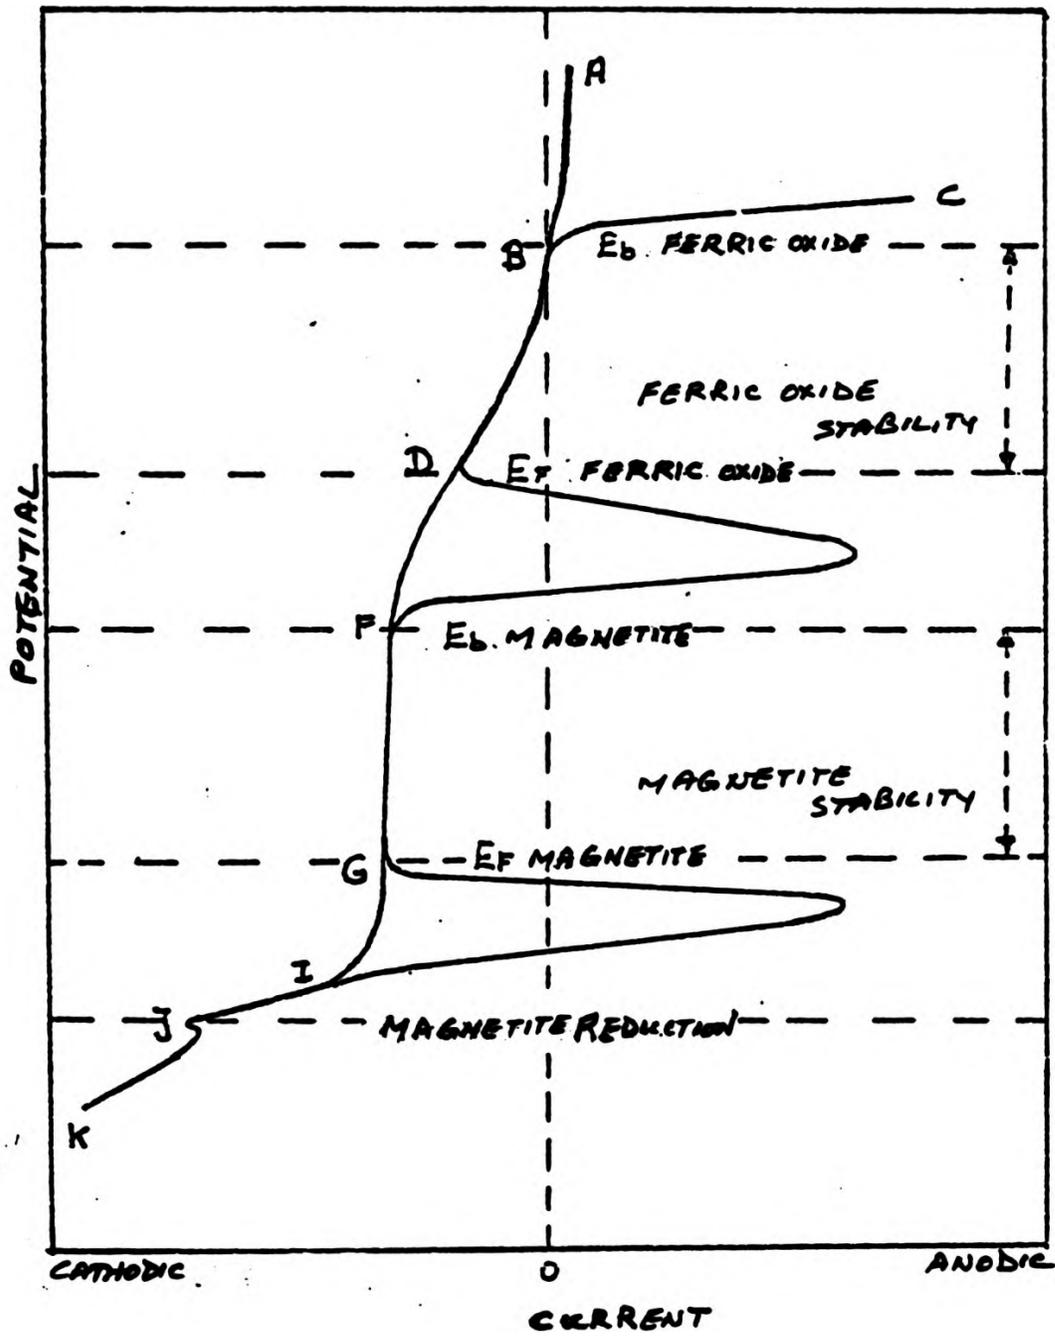
Fig D 2: Schematic polarisation curves for mild steel in air-saturated near-neutral solutions<sup>172</sup>.

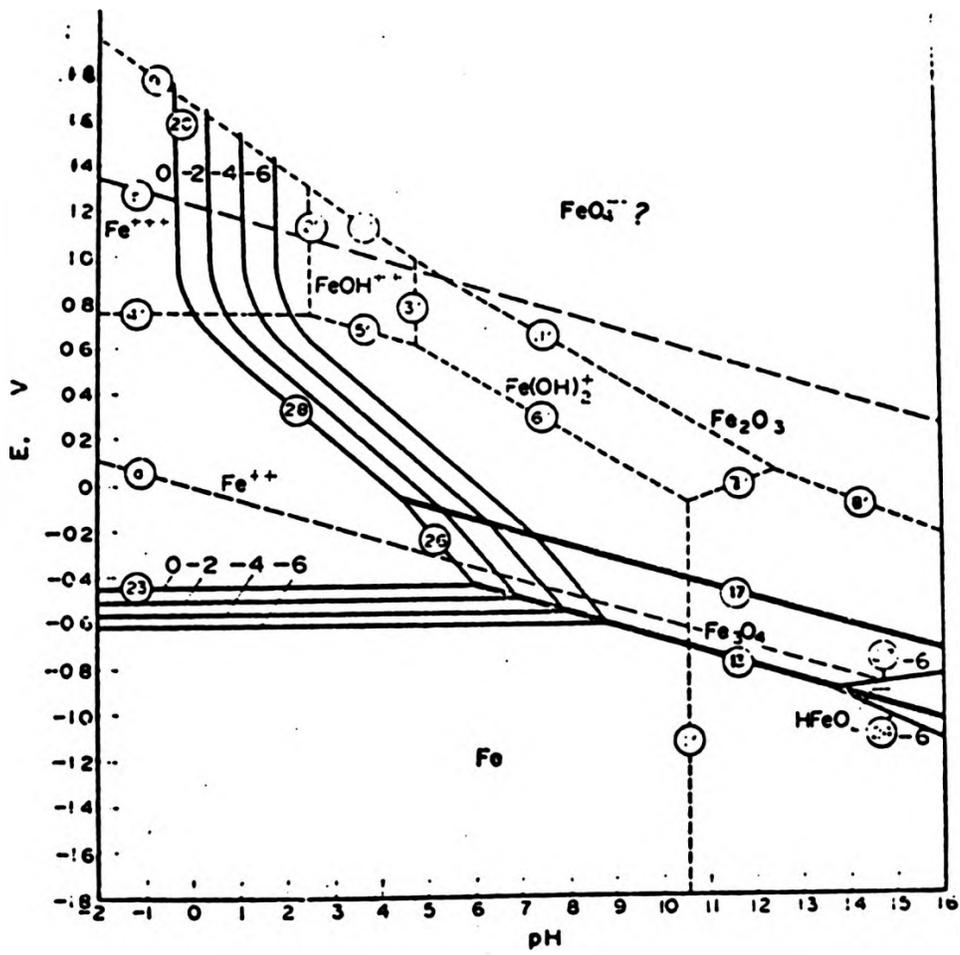
Fig D 3: Potential-pH equilibrium diagram for the iron-water system at 25°C<sup>173</sup>.

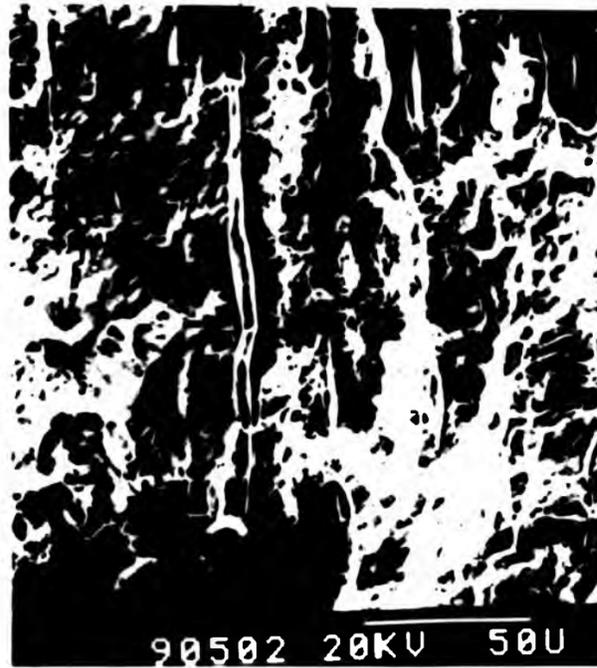
(i) Dissolution of matrix-inclusion interface after  $3.62 \times 10^5$  reversals at 193 MPa,  $R=-1$ , 47 Hz. Analysis results (ii) of the inclusion (arrowed) exhibits the presence of S (at 2.3), Mn (at 5.9) and Fe (at 6.4) only. Energy level vs intensity curve.

Fig D 5: Scanning electron micrograph of rotating bend fatigue tested specimen.

Hence it is possible that at low stresses in the early stages of the fatigue tests, some of the inclusions plastically deform because they are favourably oriented (Figure D 5). For others, dissolution, undermining and spalling appear to occur due to unfavourable orientation creating microcavities at the surface (Figures R 11g - R 11q). Initially, however, all the inclusions tend to dissolve to varying extents.

Analysis results show the presence of traces of Cr in addition to S, Mn, and Fe at most of the matrix - inclusion interfaces (Figures R 10f (ii) and R 11k, Energy level 5.4). This element was not detected at the inclusion itself (Figure R 10f (iv) and D 5). According to BS 970, Part-1, 1972, residual elements such as Cr in EN type steel are considered incidental.

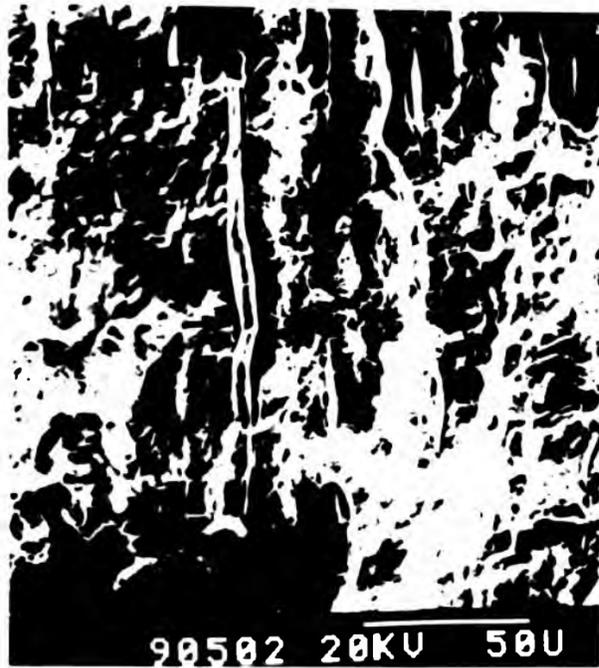
(i) Dissolution of matrix-inclusion interface after  $3.6 \times 10^5$  reversals at 193 MPa, R=-1, 47 Hz. Analysis results (ii) of the inclusion (arrowed) exhibits the presence of S (at 2.3), Mn (at 5.9) and Fe (at 9.4) only. Energy level vs intensity curve.

Fig. 5: Scanning electron micrograph of rotating bend fatigue tested specimen.

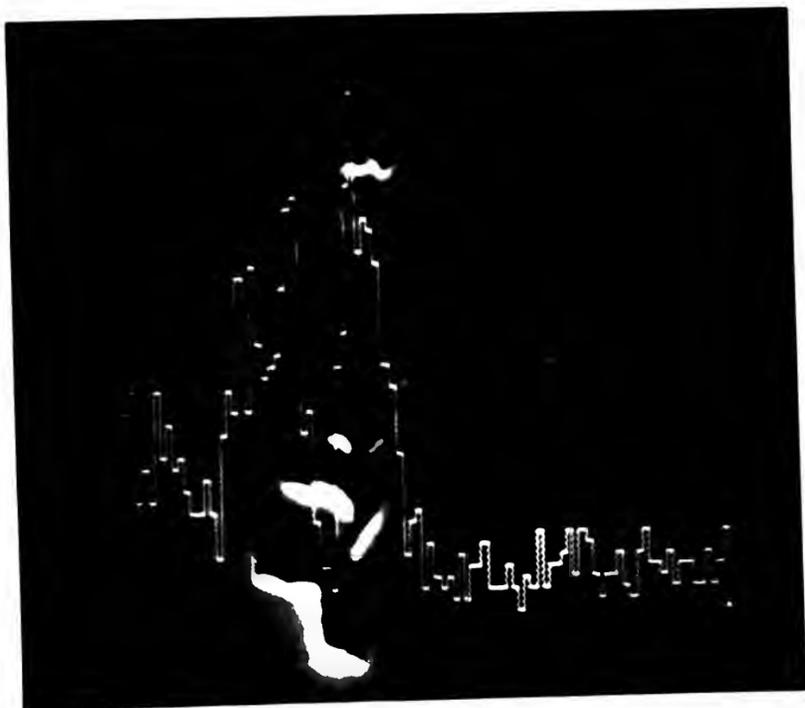
Fig. D 6: Scanning electron micrograph of an electroless nickel plated SAE 4130 steel exhibiting subsurface defects. Analysis results show concentration of  $\mu$  across the voids and in the bulk material. Left of the arrow is nickel deposit. x 1500.

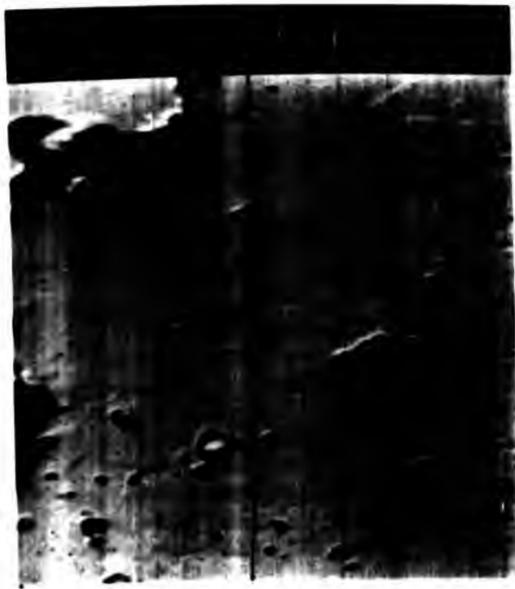
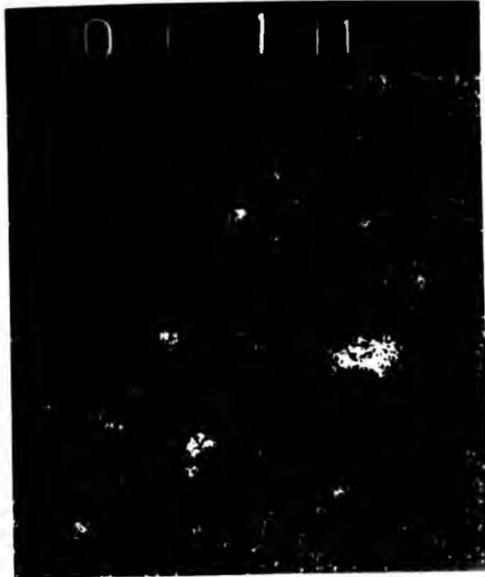
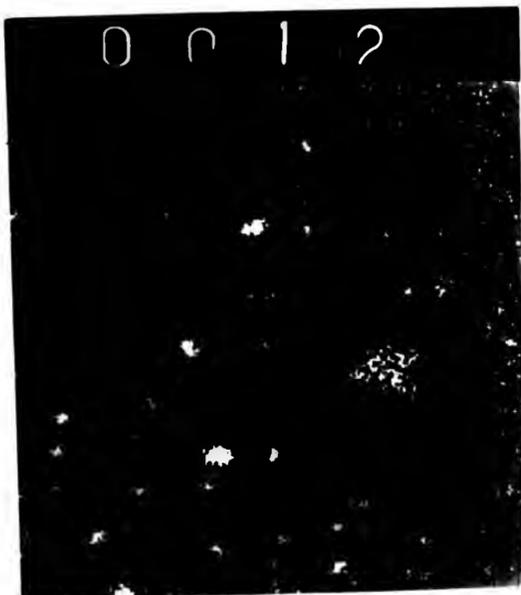
Fig D 7: Electron microprobe analysis results showing (i) the cross section of the specimen, and the presence of (ii) Mn, (iii) S and (iv) Si. Rotating bend fatigue tested specimen at 309 MPa,  $R=-1$ ,  $4.17 \times 10^5$  reversals.

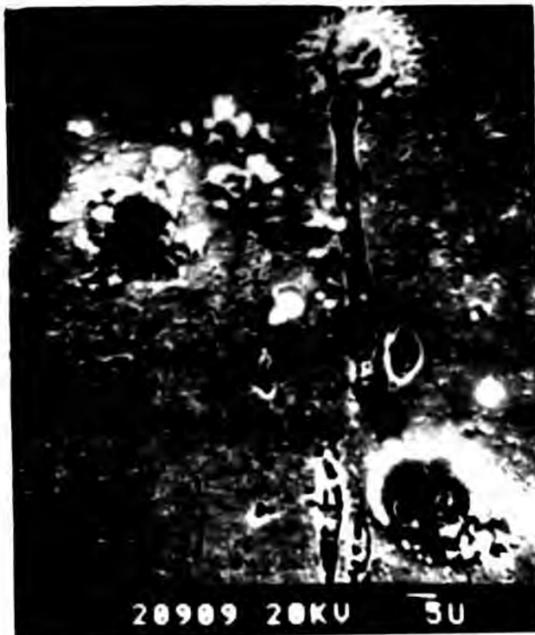
Fig D 8: Scanning electron micrograph showing dissolution of elongated and spheroidised shaped inclusions. Immersion test results after nearly 20 hours without stress.

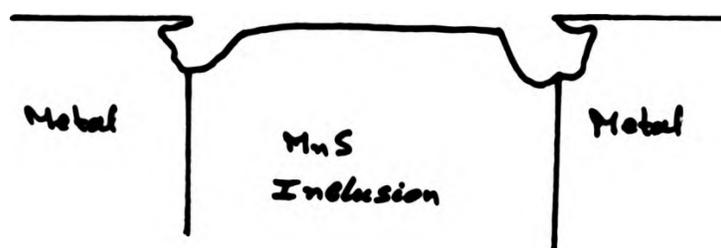
Fig D 9: Schematic diagram of continued dissolution of sulphide inclusion and incipient attack on the metal close to the inclusion.

In the high density regions, incipient attack appears to occur underneath the metal surface, close to the inclusions creating microcavities, (Figures R 11r, D 9 and D 10). Figure D 9 shows a schematic diagram of the dissolution underneath the metal surface.

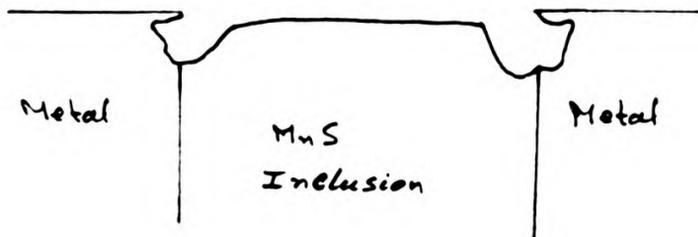
Schematic diagram of MnS inclusion in metal matrix.
