Some Aspects of Crack Initiation in Mild Steel Subjected to  
Fatigue Stressing in a Corrosive Environment

G P Ray BSc MSc CEng MIM MICorrT MIMF

A report presented in partial fulfilment of the requirements  
of the PhD Degree of COUNCIL OF NATIONAL ACADEMIC AWARDS.

City of London Polytechnic  
Sir John Cass School of Science  
and Technology  
Department of Metallurgy and Materials  
LONDON

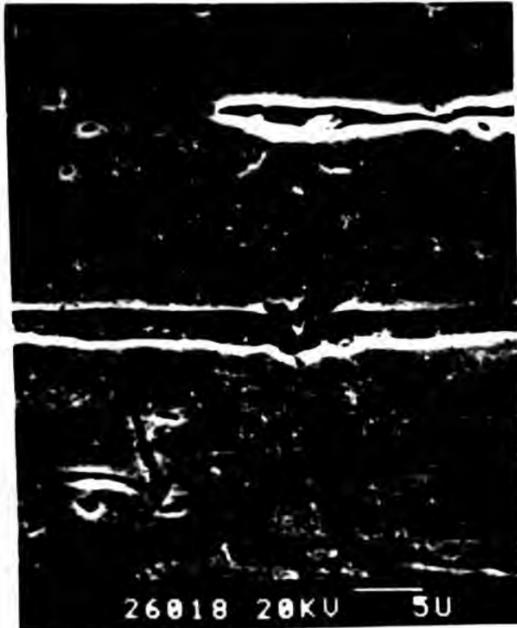
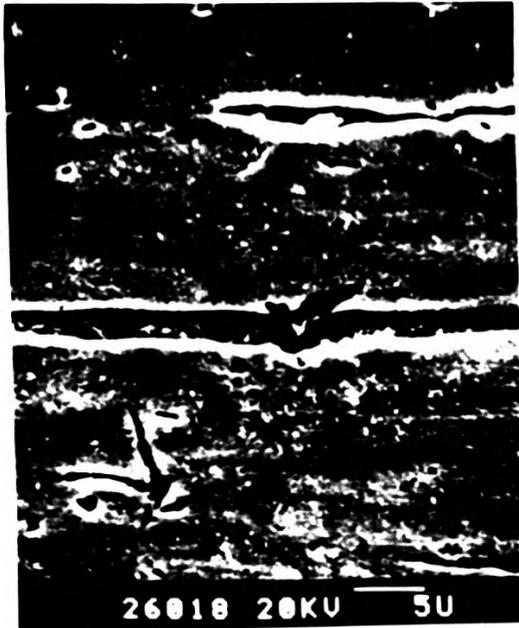
Fig D 11: Scanning electron micrograph of a wrought specimen after 2000 reversals at 278 MPa, R=-1, showing incipient crack formation from an inclusion.

Fig D 11: Scanning electron micrograph of a wrought specimen after 2000 reversals at 278 MPa, R-1, showing incipient crack formation from an inclusion.

If the sulphide inclusions are further apart, then incipient cracks also tend to form but the lateral extension of the microcavities is not sufficient to breach the ligaments (Figure D 11). This incipient crack formation also occurs at etch pits (Figure D 12), in pearlitic areas (Figure R 11e) and at grain boundaries (Figure R 11u).

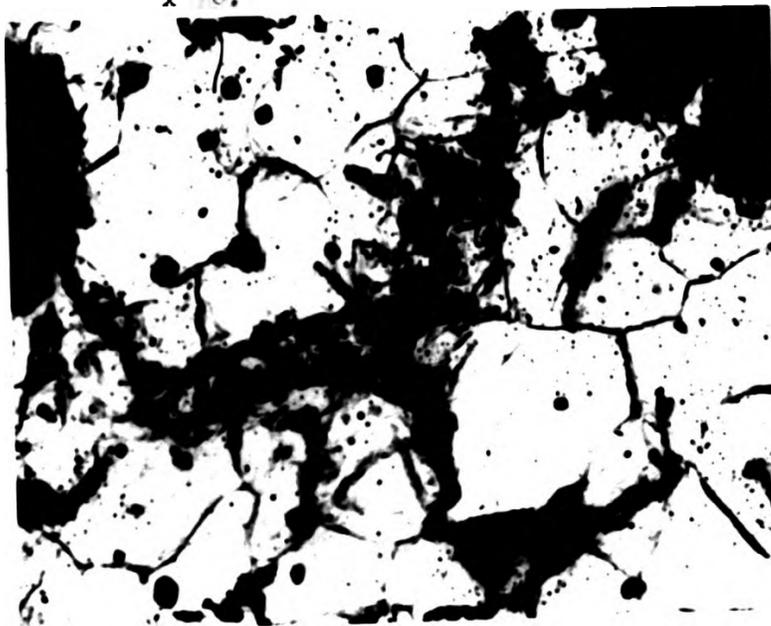
Fig D 18: Micrograph of a fractured surface of a rotating bend fatigue tested specimen at 177 MPa, R=-1, after  $10^6$  reversals exhibiting linking up of adjoining pits.  
x 700.

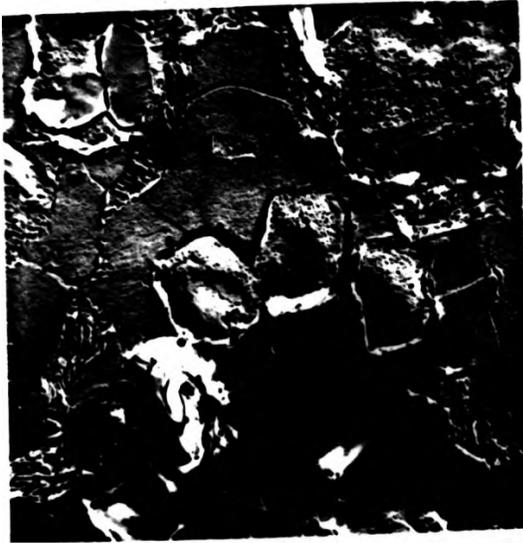
Fig D 20: Transmission electron micrographs of wrought specimen showing (i) linking of adjacent pits by dissolution along grain boundaries and pearlitic regions, x 2182, and (ii) etch pits at the tip of a fissure in a pit, x 6818. 197 MPa, R=-1,  $7.86 \times 10^5$  reversals.

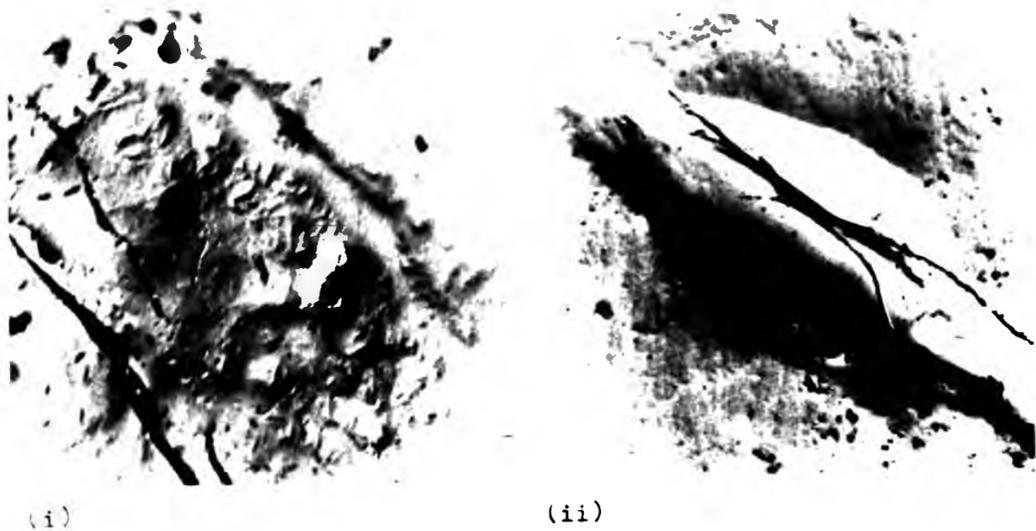
Fig D 19: Transmission electron micrographs of wrought specimen showing (i) micropits in the slip band and microcracks at the matrix-slip band interface, and (ii) linking of micropits creating microcracks in the slip band. Outside corroded zone, 247 MPa, R=-1, after  $10^6$  reversals; x 16273 and x 11273 respectively.

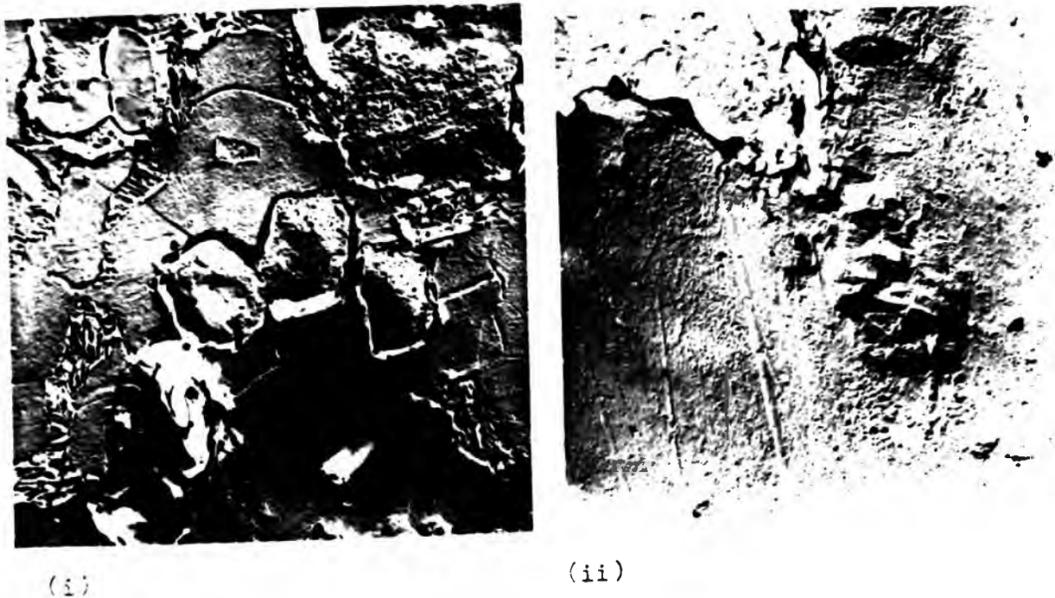
Fig D 20: Transmission electron micrographs of wrought specimen showing (i) linking of adjacent pits by dissolution along grain boundaries and pearlitic regions, x 2182, and (ii) etch pits at the tip of a fissure in a pit, x 6818. 197 MPa, R=-1,  $7.86 \times 10^6$  reversals.

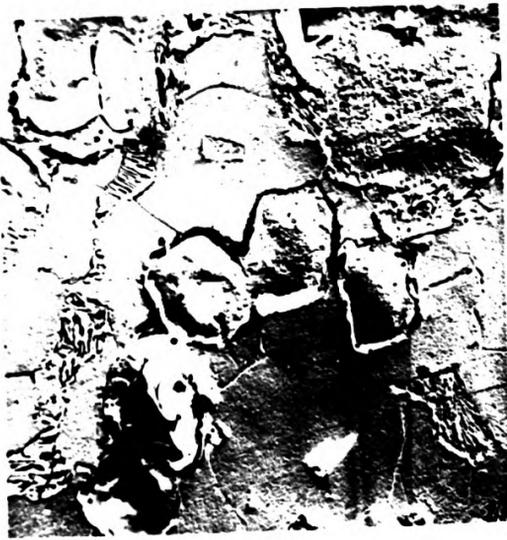
Fig. 20: Transmission electron micrographs of wrought specimen showing (i) matrix-slip band interface with micropits and microcracks, and (ii) linking of micropits creating microcracks in the slip band. Outside corroded zone, 242 MPa, R=-1, after  $10^6$  reversals; x 5117 and x 5117 respectively.
